Inventory and Risk Assessment of Historic Caribou and Sheep Fences in the NWT

Climate Change Preparedness in the North
Program Project 2017-06

**Cultural Places Program
Culture and Heritage Division
Department of Education, Culture and Employment
Government of the Northwest Territories**

May 8, 2019

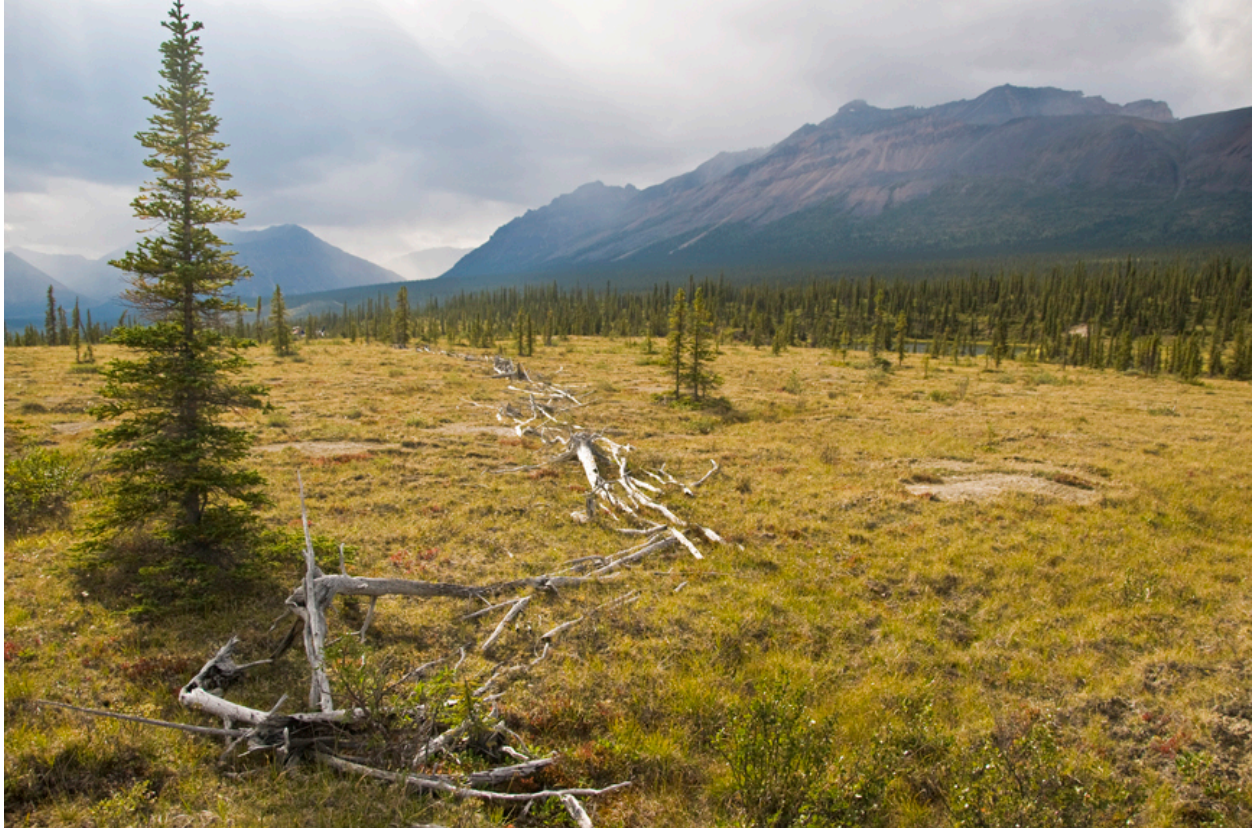
KjRx-1	2009	2010 2016	This site consists of three sections of fencing that	2009: The fence is largely collapsed but a continuous fence

Fence	Year First Recorded	Year(s) Revisited	Description	Most Recent Observed Condition
		2017	together total >800 m in length. It is associated with a mineral lick. A high resolution map and orthophoto has been created for this fence using an UAV, and the fence has been dated through dendrochronological analysis.	line is visible and well-preserved.
LeRu-3	1989		This feature consists of a spruce pole sheep fence. It is located on the west side of the Carcajou River on the western slope of a north-south trending ridge.	In 1989 this fence had collapsed and was overgrown with birch shrubs, but the fence line was still visible.
LfRw-1	1989	2007	This site is a well-preserved boulder and pole sheep fence, located on a ridge near Katherine Creek. The fence lies perpendicular to the long axis of the ridge. A prominent sheep trail runs the length of the ridge. The fence was mapped by GPS in 2007.	2007: Wood snare poles collapsed but well-preserved.

Figure 2: Example of caribou fence (KjRx-1) in the Mackenzie Mountains. Photo: Tom Andrews.
