Contract ID: SC-INF01-1469  
Our File #: 18-304

## **INF Carpentry Shop Foundation Pile Condition Assessment**

**Regarding: INF Carpentry Shop**  
**Location: 40 Veterans Way, Inuvik, NT**

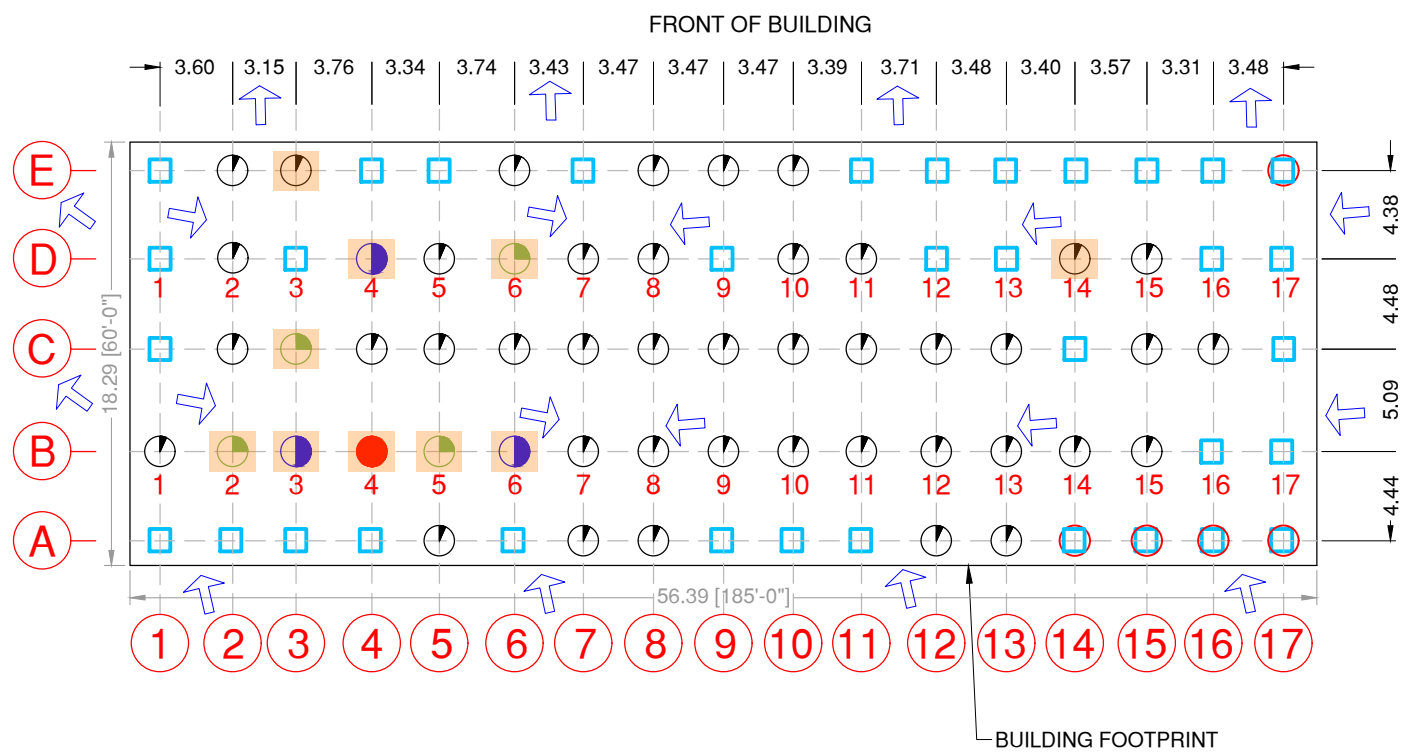
**PILE RATINGS**  
(% CROSS-SECTION LOSS)

Of the piles inspected, ten piles were damaged to the point of needing repair; four (B2, B5, C3 and D6) had non-structural surface damage that requires surface repairs; four (B3, B4, B6 and D4) had structural damage and require full repair; two piles (D14 and E3) were determined to be too small and require full repair; and 30 of the piles had previously been repaired using steel caps.

a slightly higher elevation than some of the ground beneath the building resulting in some moisture accumulation below the building. The effect of the moisture accumulation below the building is considered moderate and is impacting the pile integrity.

The first step in a remedial action is to minimize the amount of standing water and exposure to runoff. Based on this analysis the drainage issue is considered to have a moderate effect on the piles, and remedial actions are recommended. The placement of a catch basin and drain to assist drainage from beneath the building is recommended. Based on site conditions there appears to be adequate relief to the west to drain the area. Since the parking lot is paved to the southwest the installation of a storm drain system on the north end of the pavement seems like the most cost-effective option.

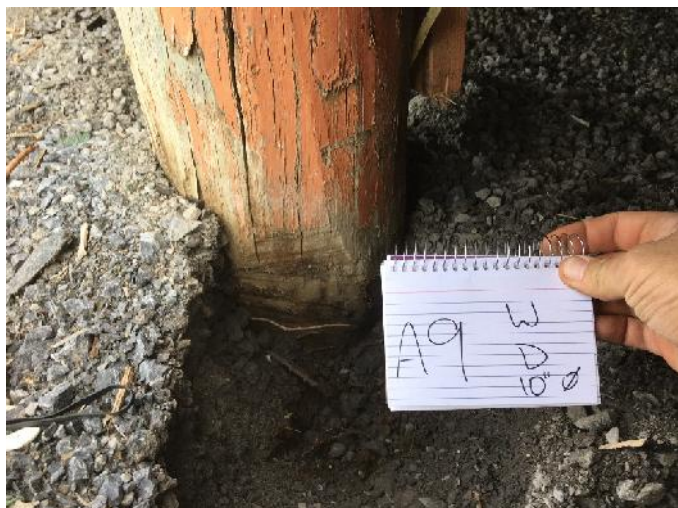
E9 – Incorrectly labelled as A9
