Contract ID: SC-INF01-1469  
Our File #: 18-304

## ENR Office

## Foundation Pile Condition Assessment

**Regarding: ENR Office Foundation Pile Condition Assessment**  
**Location: Lot 4 Block 91, Inuvik, NT**

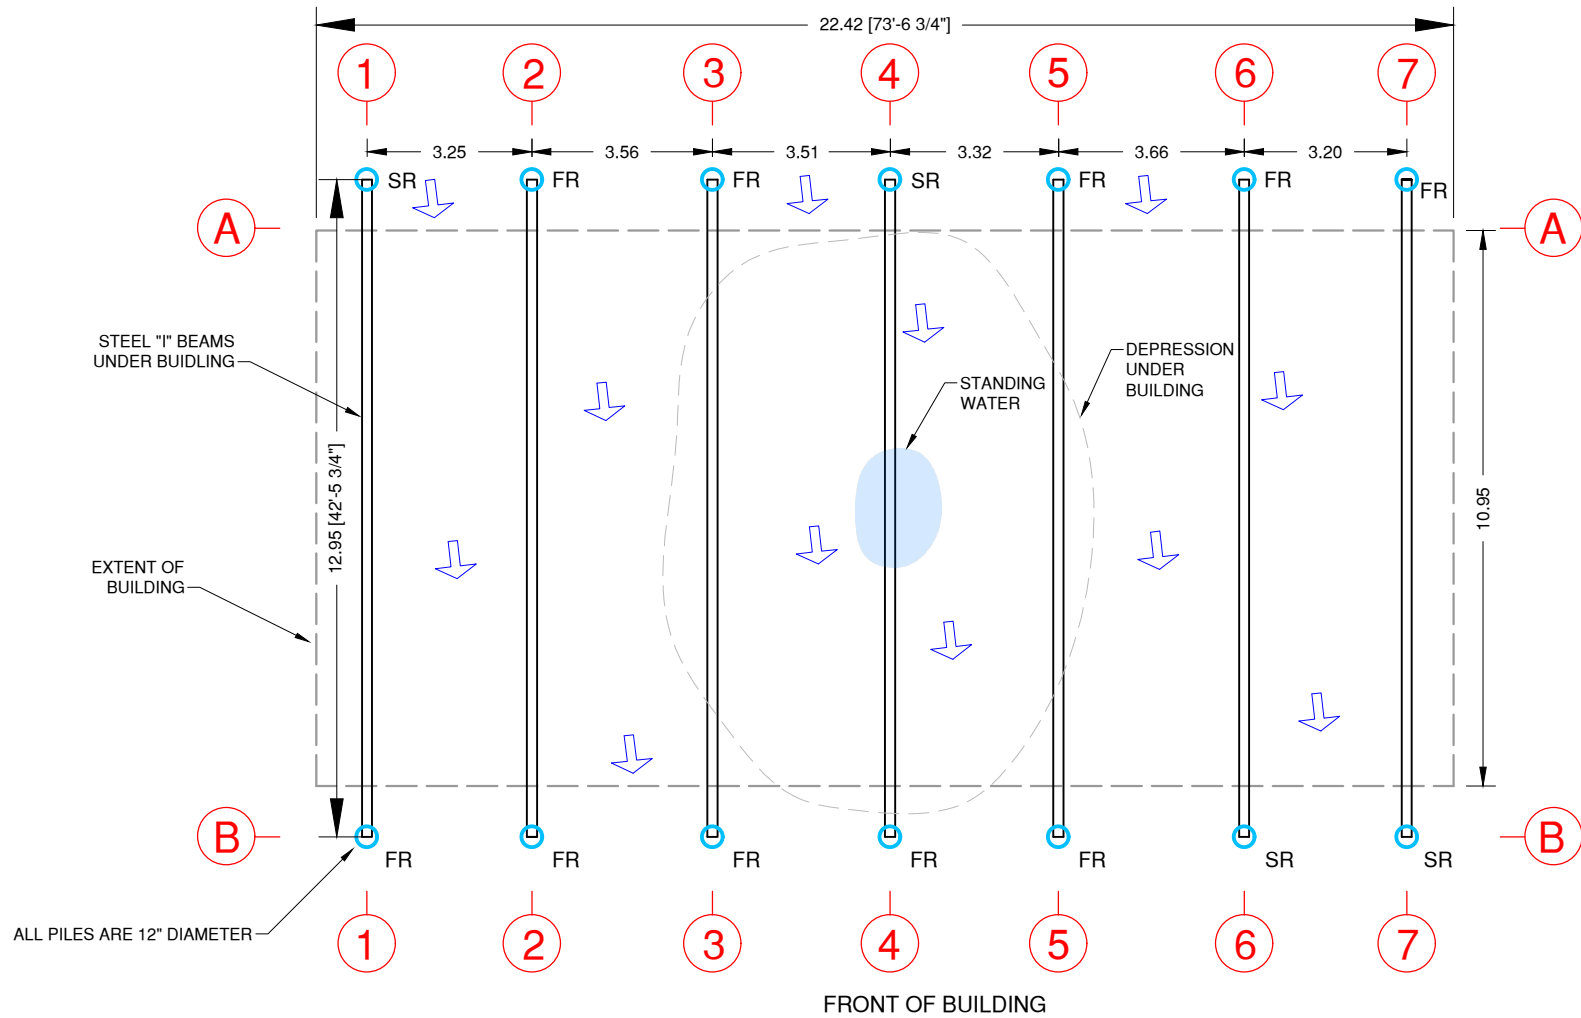
PROJECT NUMBER	18-304
VERSION NUMBER	IFA1-1
DATE DRAWN	JULY 4, 2018
SHEET NUMBER	<b>FIG. 1</b>

The results of the site inspection showed that piles A1, A4, B1, B7 had minimal surface rust with no penetration while the rest of the steel piles had flaking rust. There was some standing water in the depression under the building (refer to attached photographs in [Appendix C](#)) but none observed at or around the piles. The overland drainage appears to flow from the northeast down towards the southwest.

The ENR office building rests on fourteen, 12-inch diameter exterior steel piles located outside the building footprint which support seven (7) steel beams that span from pile to pile underneath the building (refer to **Figure 1**). The ground around each pile was excavated to a maximum depth of 500mm below ground ensuring that each pile was sufficiently exposed for inspection. A visual inspection as well as a “scratch” test was performed for each steel pile to assess the extent of impact below the ground surface. In addition, an evaluation of drainage patterns was conducted. The drainage flows from the northeast to the southwest. There was standing water observed in the depression beneath the building and the overland drainage appears to flow from the northeast down towards the southwest. The existing ground topography around the office building varies which contributes to surface runoff ponding beneath the building.

The results of the site inspection showed that piles A1, A4, B1, B7 had minimal surface rust with no penetration while the rest of the steel piles had flaking rust below ground level. Based on this analysis the foundation appears to be performing as designed and no repairs or replacement actions are recommended at this time.

Based on this analysis the existing steel piles are in good working condition any observed rust or deterioration was minimal and not of concern. No repair or replacement action is recommended at this time.

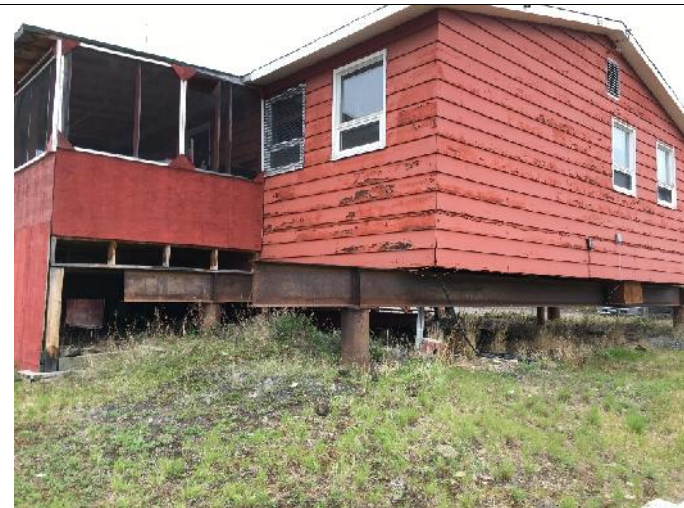
Southeast corner of office building

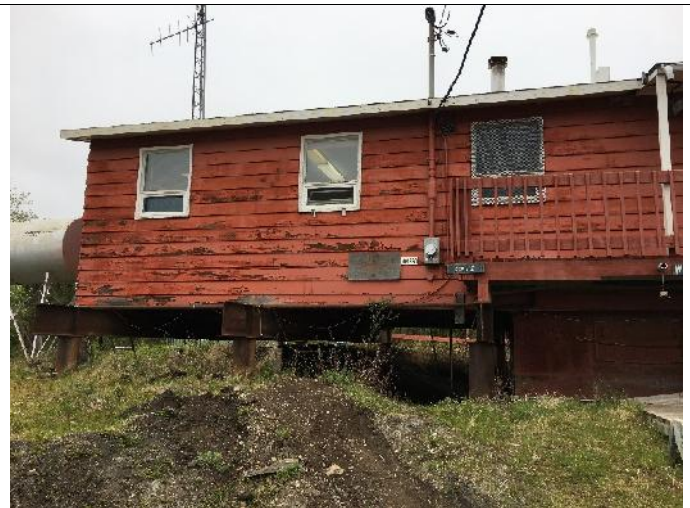
Southwest corner of office building

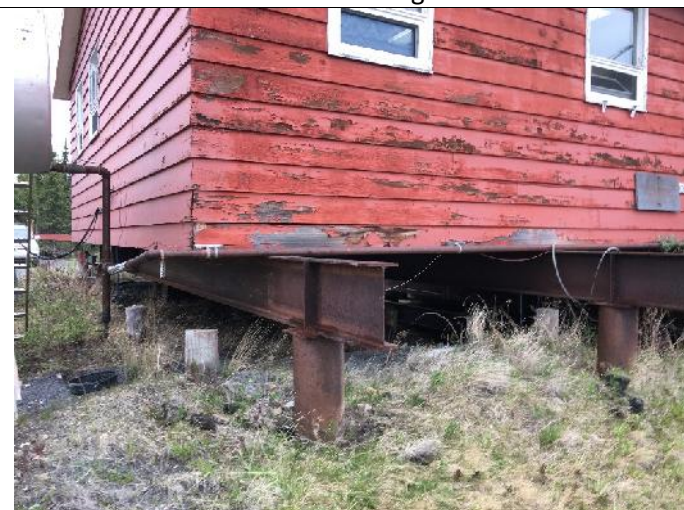
Southwest corner of building. Cutoff wood piles visible

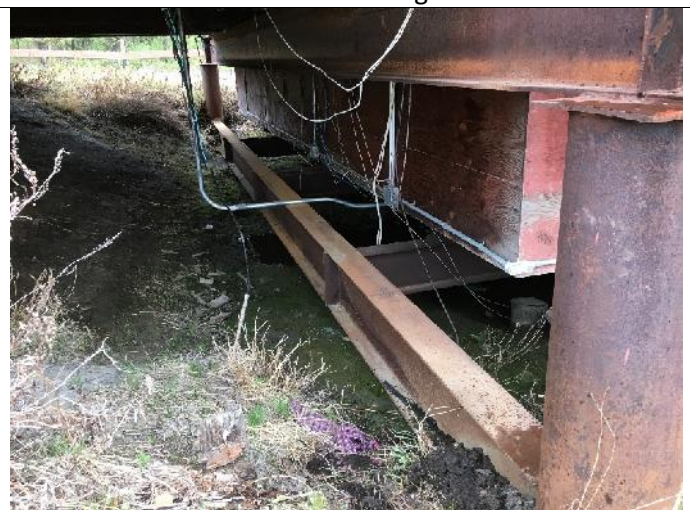
Regarding the standing water was observed below the building, it is good construction and design practice to prevent standing water near structures. However, modifying the drainage at the site is difficult due to the nature of the surrounding area. In this case, the ponding does not directly affect the piles. As such, there is no immediate need, from a structural perspective, to drain the impacted areas or revise the grading around or under the building.

Low spot under middle of building with standing water
