**Sanayut Consulting Professional
Engineers Corporation**

Deline Health Centre Foundation Pile Condition Assessment

Regarding: Deline Health Centre-Foundation Pile Condition Assessment
Location: Lots 3 – 6, Plan 5182, Deline, NT

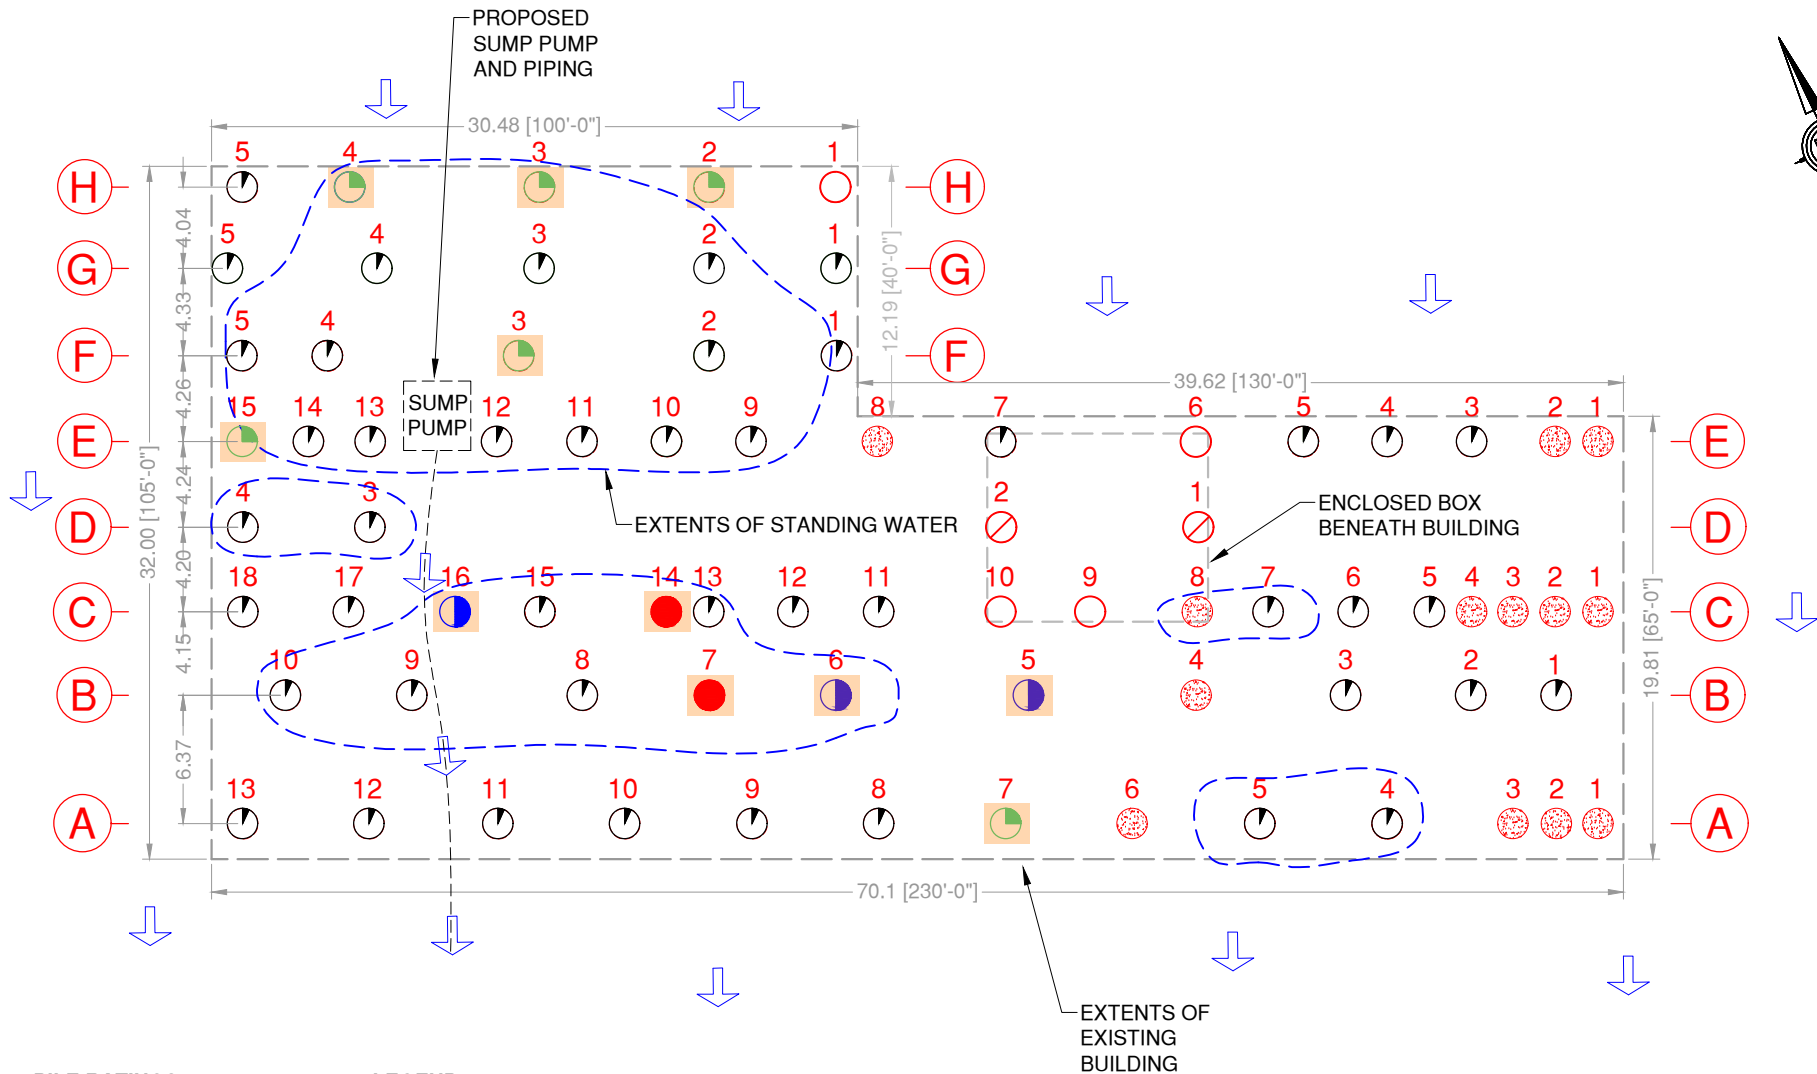
Deline Health Centre	Recommendations
Total Piles	75	
< 10% damage	47	No repair
10-25% damage	6	Surface repair – Piles A7, E15, F3, H2 – H4
25-50% damage	3	Full repair – Piles B5, B6, C16
>50% damage	2	Full repair – Piles B7 & C14
Concrete repair	13	None
Not inspected/unknown	4	Piles not accessible due to enclosure

Overall the drainage onsite was from north to south. A significant degree of standing water or lack of drainage was observed at this location. Drainage modification will be required.

Overall the drainage onsite was from north to south. A significant degree of standing water or lack of drainage was observed at this location. To improve the surface drainage, a combination of creating a swale to the south and filling low spots under the building with gravel (20 mm minus) is recommended.

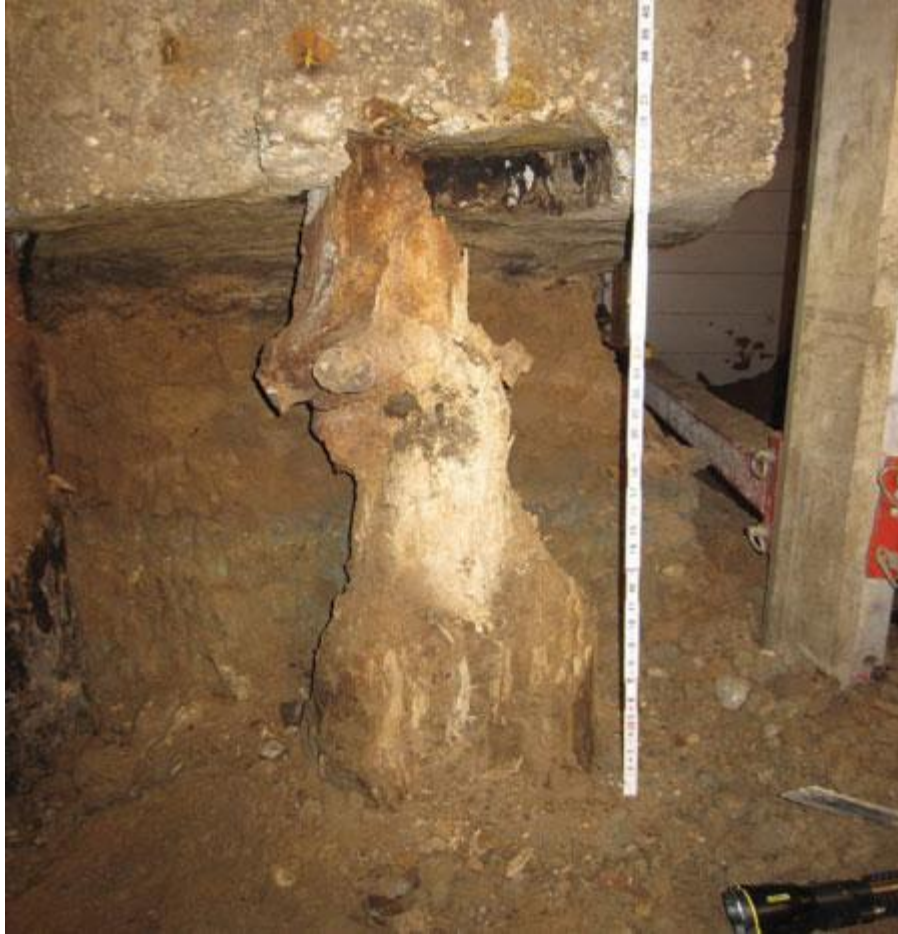
Figure 3. Example of severely decayed timber pile below concrete pile cap at Test Pit No. 1

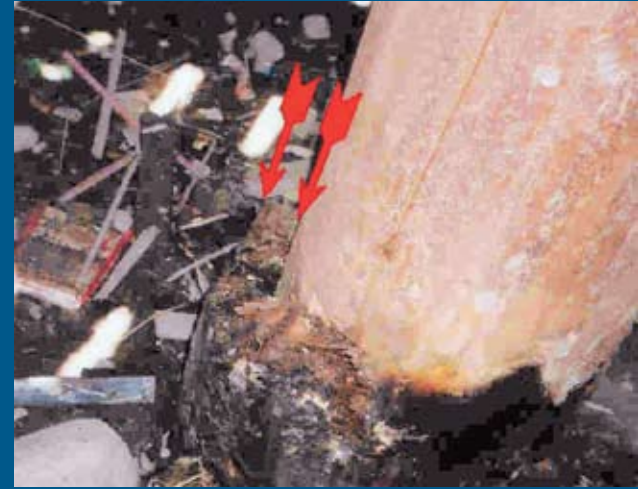
Total pile collapse and shift at ground level.

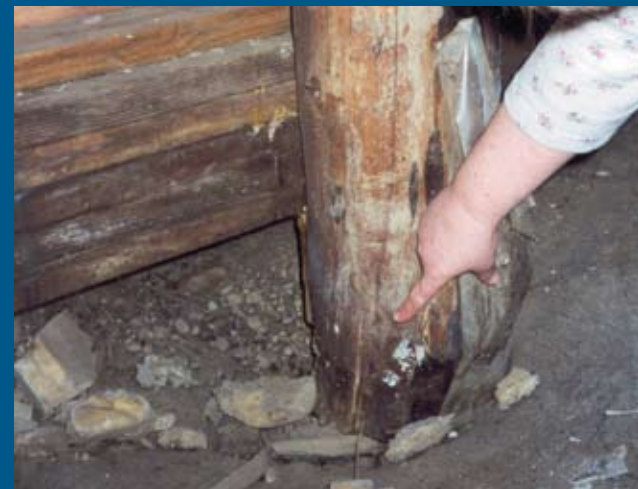
Depression holds water around pile, speeding up rot.

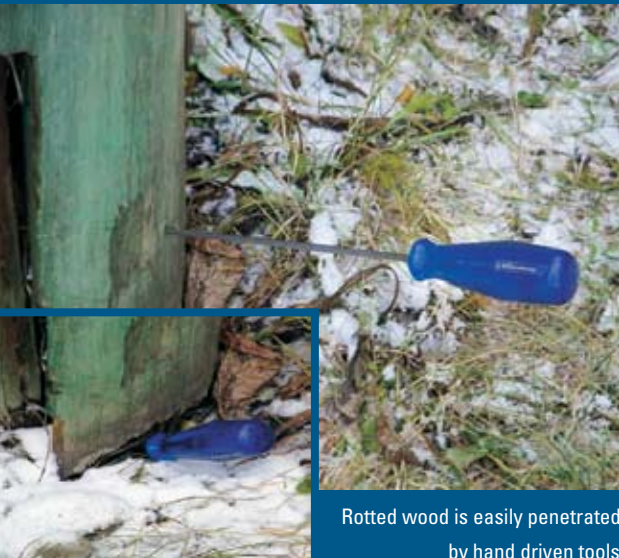
Rotted wood is easily penetrated by hand driven tools.

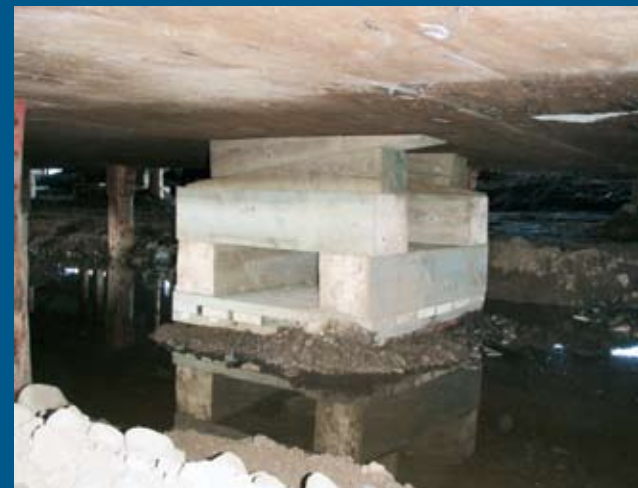
Wood crib blocking provides interim support for failed pile. Water must be drained to eliminate frost heaving.
