Contract ID: SC-INF01-1469  
Our File #: 18-304

## **Old MACA Warehouse Foundation Pile Condition Assessment**

**Regarding: Old MACA Warehouse**  
**Location: 43 Veterans Way, Inuvik, NT**

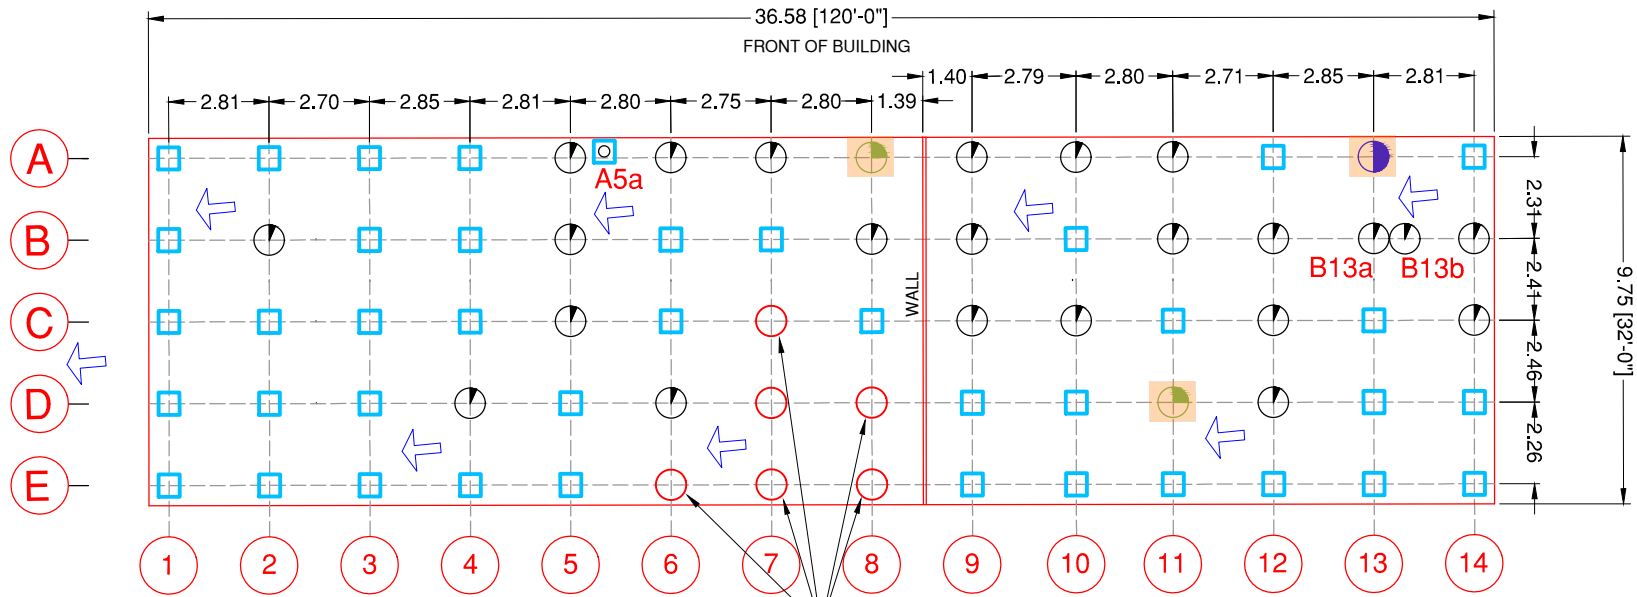
Piles requiring repair       Original wood piles

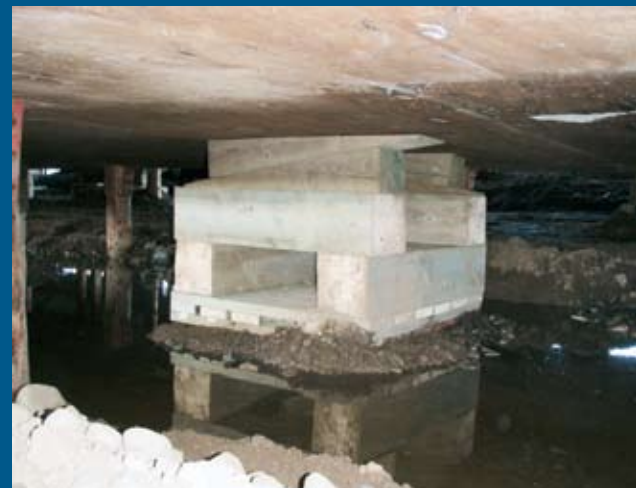
Wood crib blocking provides interim support for failed pile. Water must be drained to eliminate frost heaving.
