Contract ID: SC-INF01-1469  
Our File#:18-304

## **Juk Territorial Park Tower Foundation Pile Condition Assessment**

**Regarding: Existing Pile Foundation Investigation – Juk Territorial Park Tower**  
**Location: Juk Territorial Park, near Inuvik, NT**

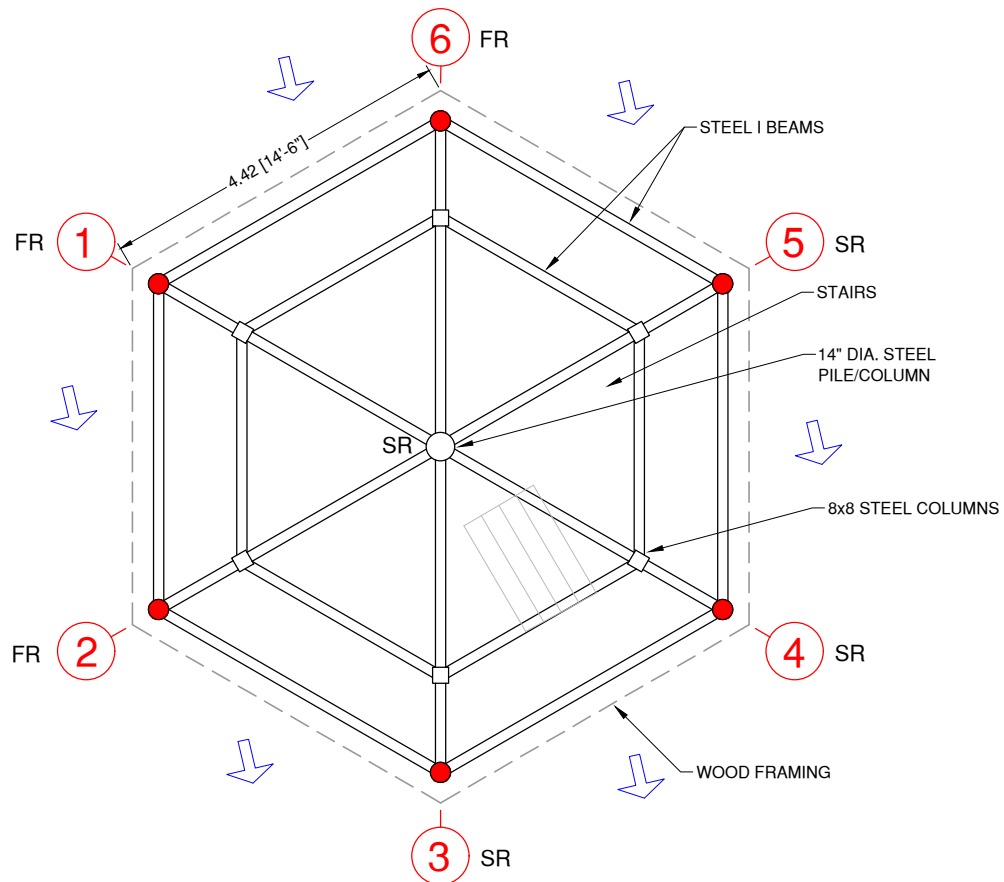
PROJECT NUMBER	18-304
VERSION NUMBER	IFA1-1
DATE DRAWN	JULY 30, 2018
SHEET NUMBER	<b>FIG. 1</b>

The tower is currently supported by 6 exterior steel piles, each being 10 inches in diameter. The central pile/column is a 14" diameter steel pile (refer to Figure 1). The ground around each pile was excavated to a maximum depth of 500mm below ground ensuring that each pile was exposed up to 180 degrees around for inspection. A visual inspection as well as a "scratch" test was performed for each steel pile. The results of the site inspection showed that each steel pile had minimal surface rust with no penetration or flaking steel. There was no standing surface water observed at the site and the overland drainage direction appears to be to the southeast.

Based on this analysis, the existing steel piles are in good working condition and any observed rust or deterioration was minimal and not of concern. No repair or replacement action is recommended at this time.

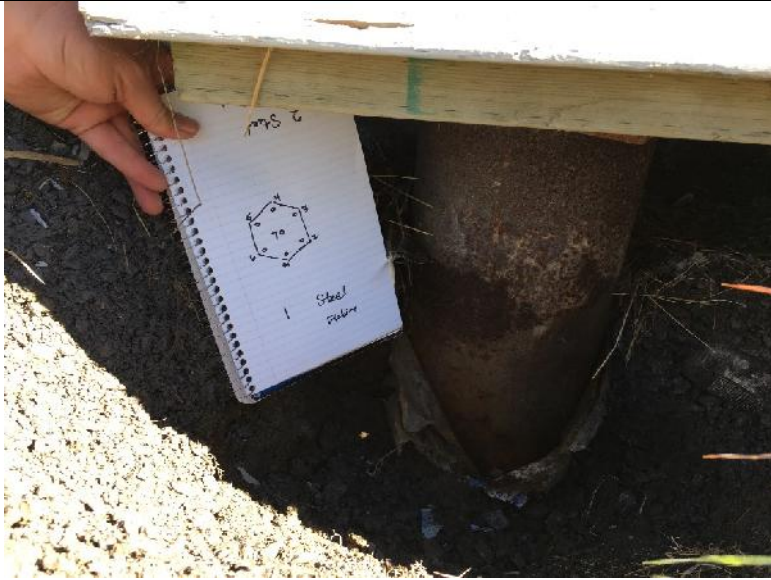
Photograph 1

Pile #1  
Flaking rust observed

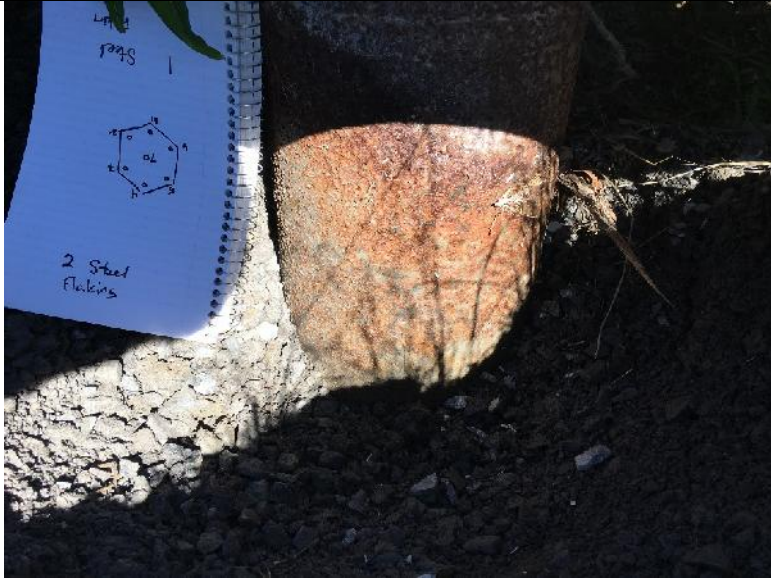
Photograph 2

Pile #2  
Flaking rust observed

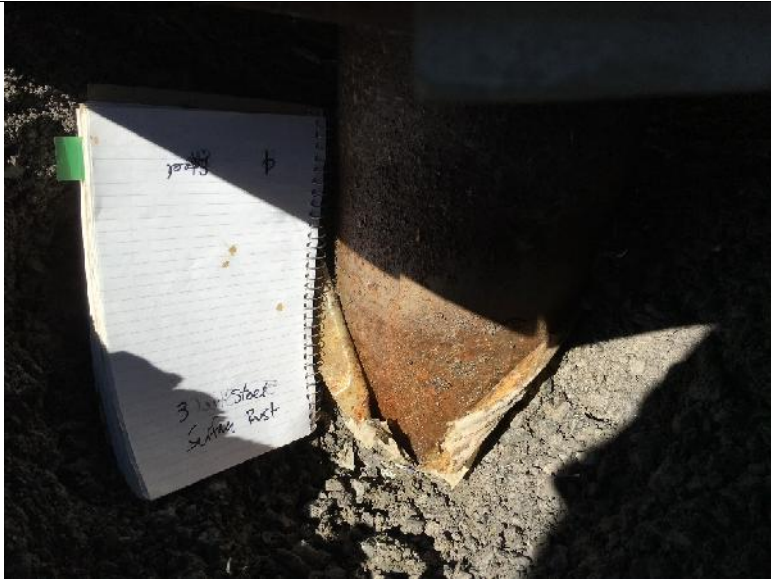
Photograph 3

Pile #3  
Surface rust observed

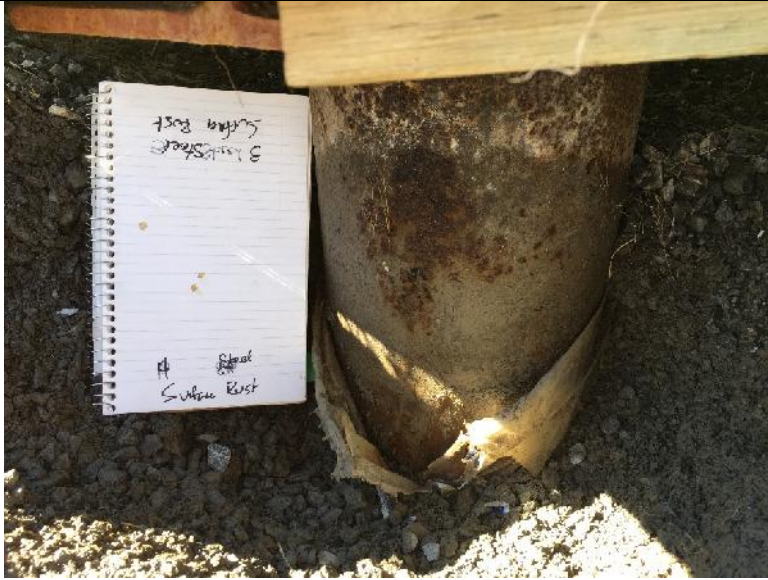
Photograph 4

Pile #4  
Surface rust observed

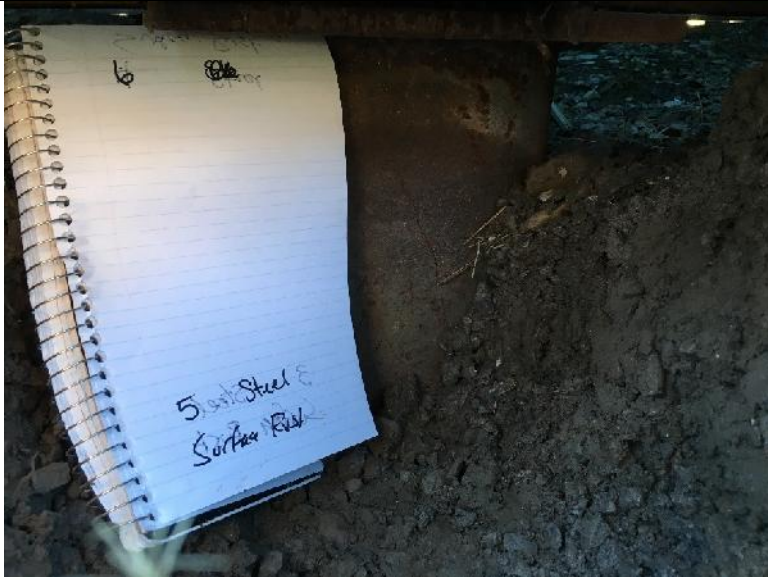
Photograph 5

Pile #5  
Surface rust observed

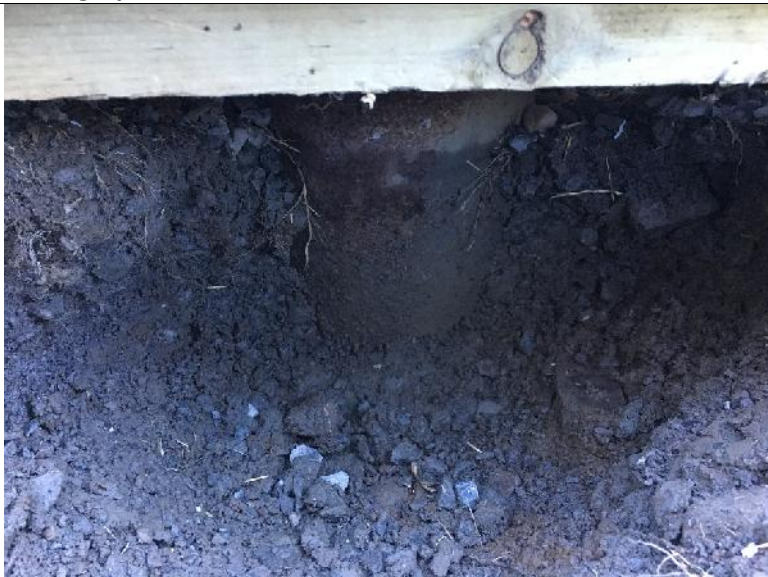
Photograph 6

Pile #6  
Flaking rust observed

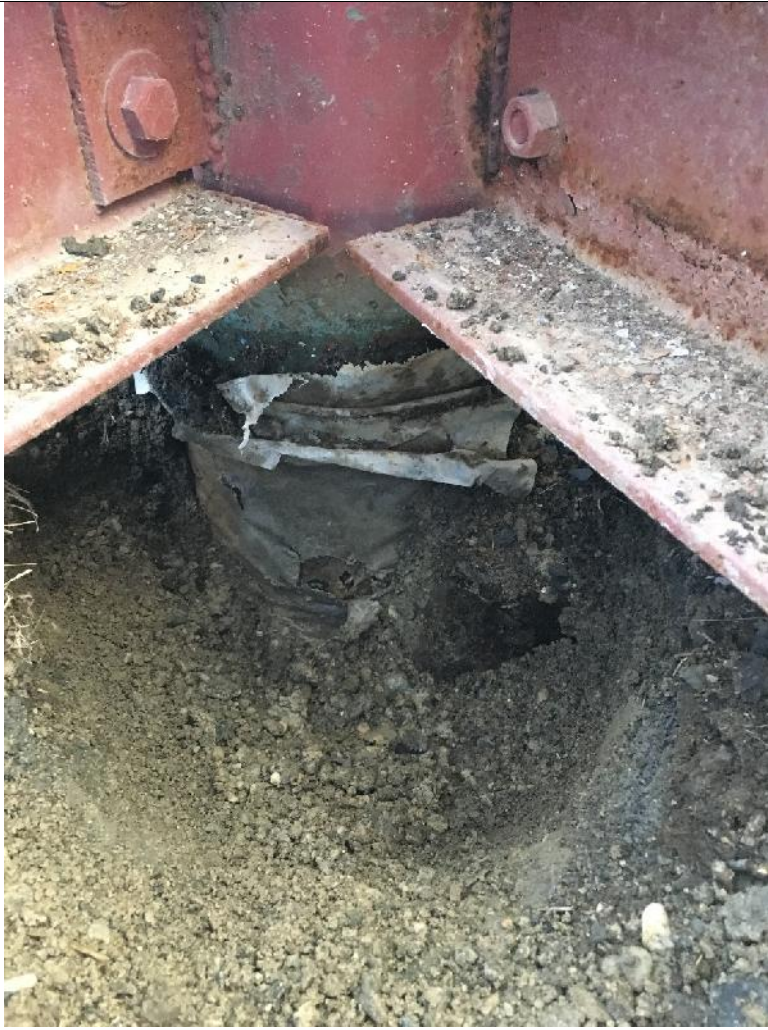
Photograph 7

Center Pile/Column  
Surface rust observed
