Contract ID: SC-INF01-1469  
Our File #: 18-304

**Sanayut Consulting Professional  
Engineers Corporation**

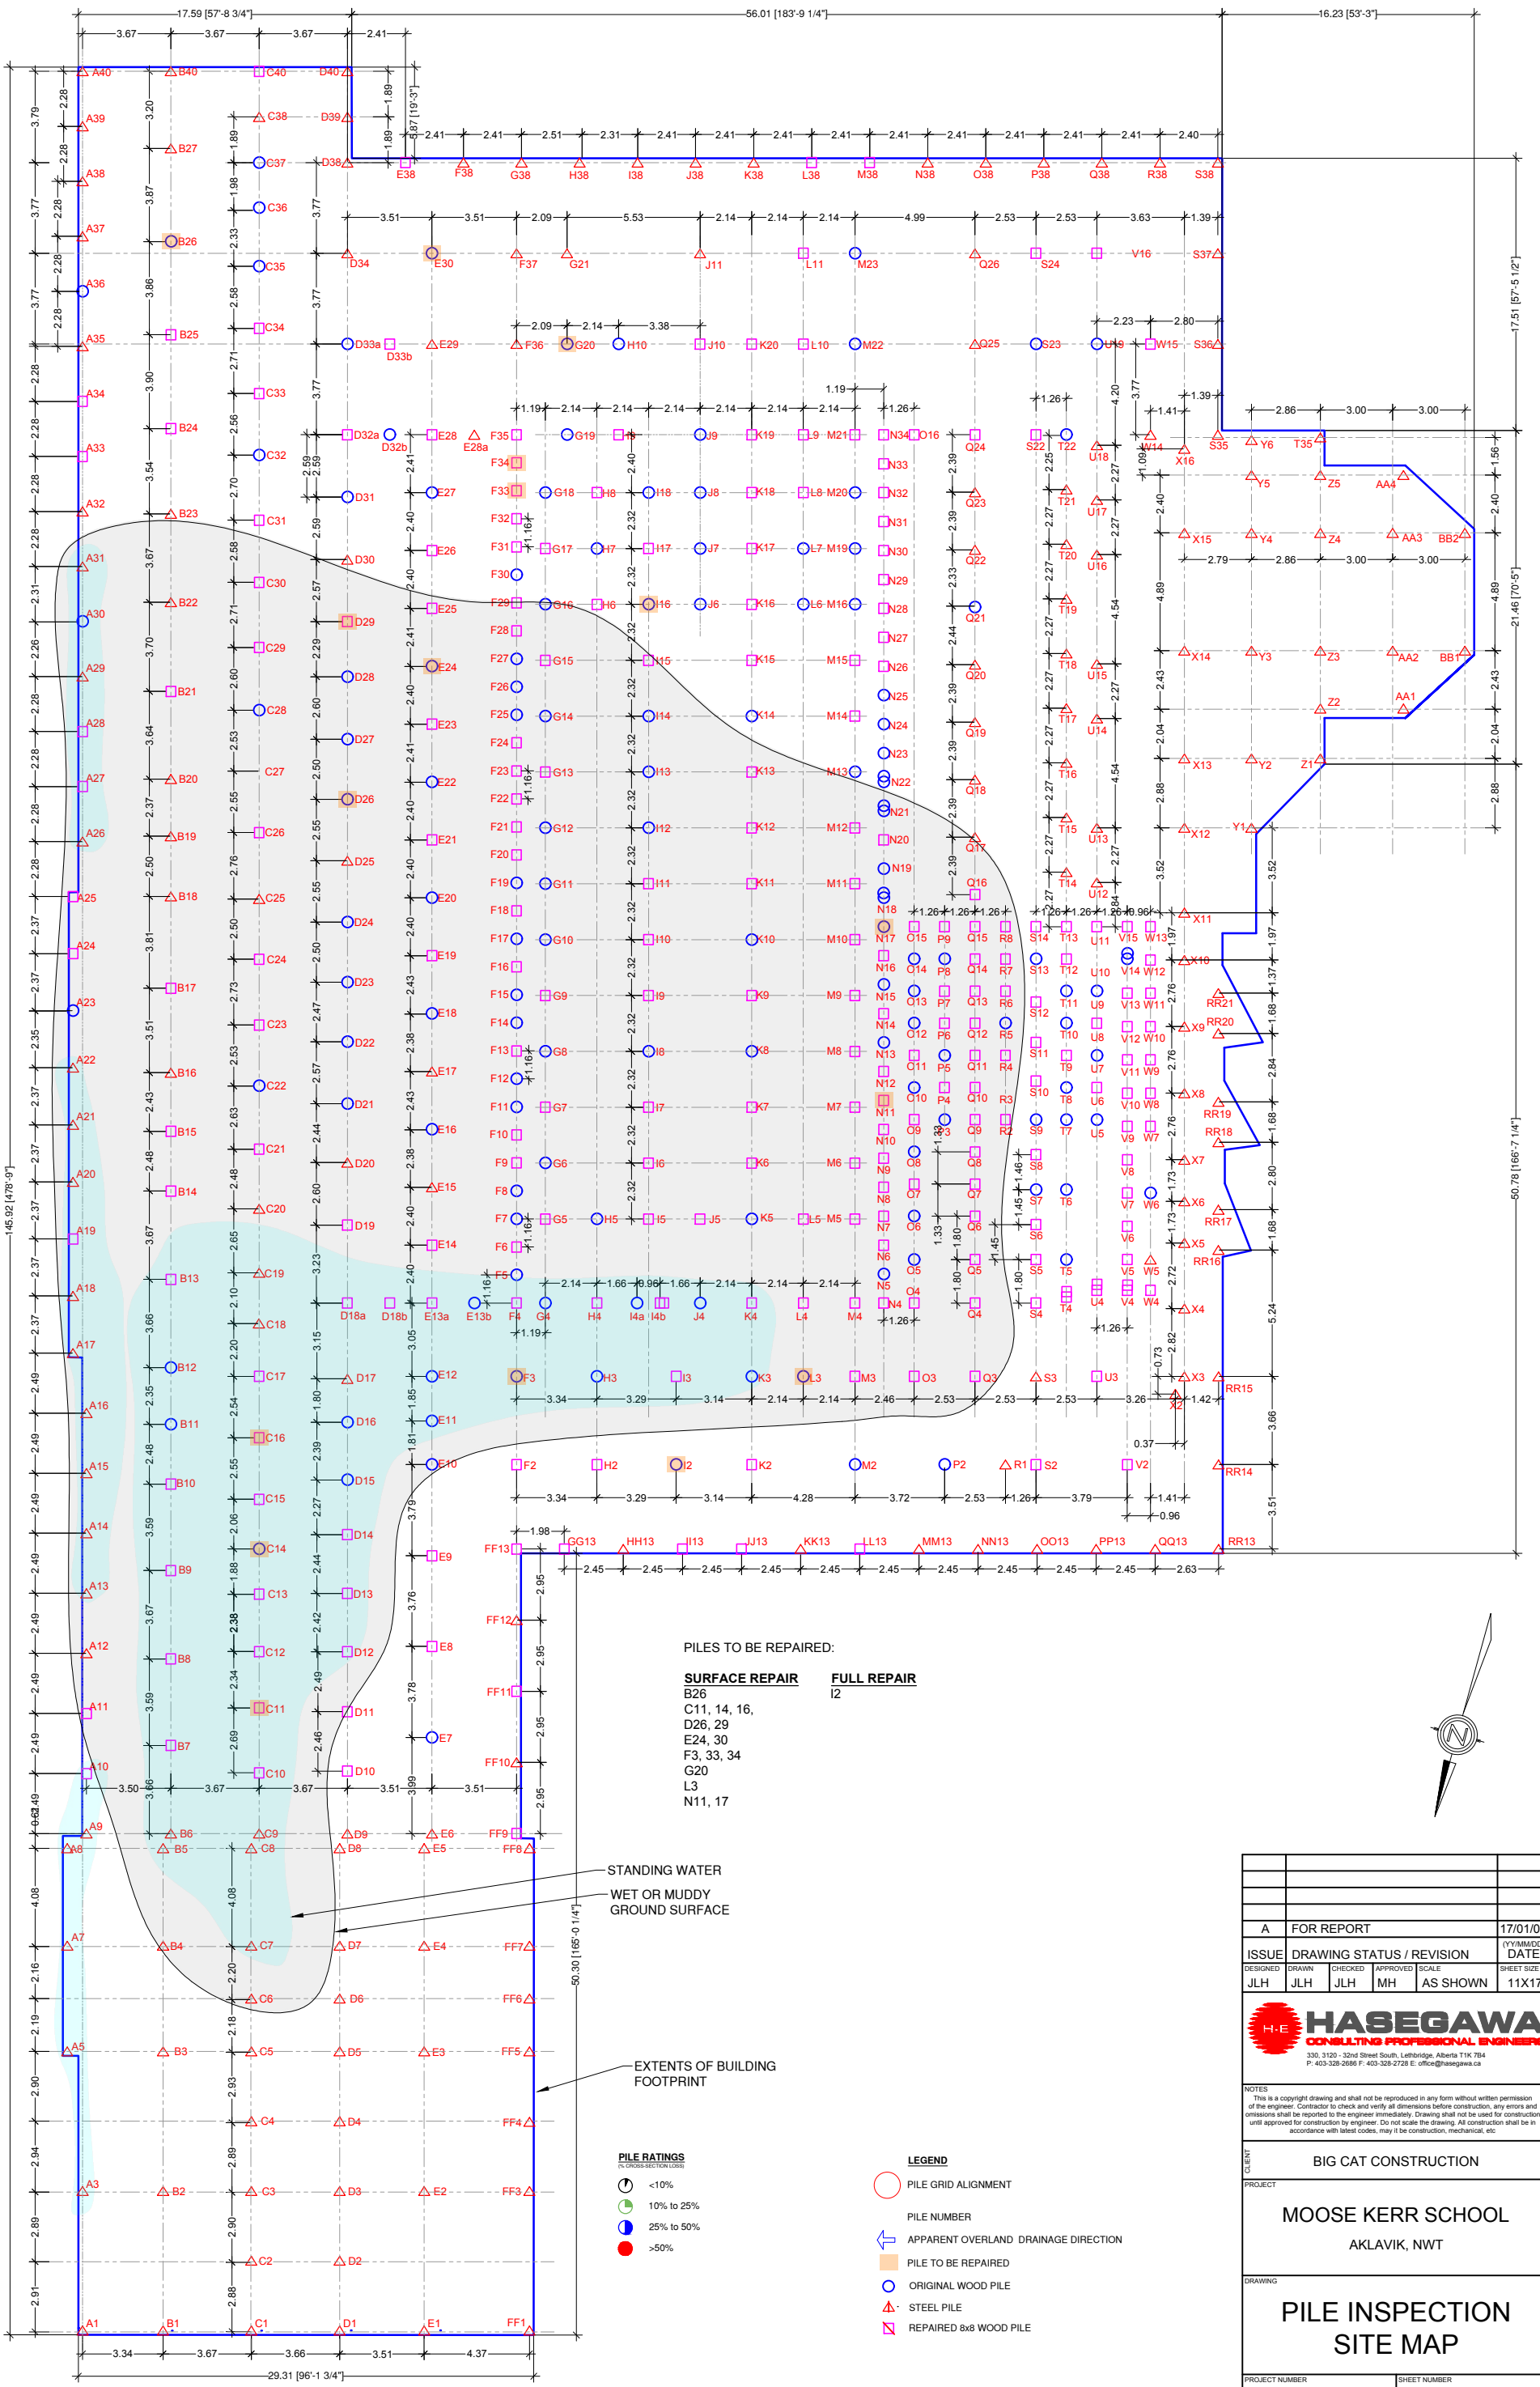
PILES TO BE REPAIRED:

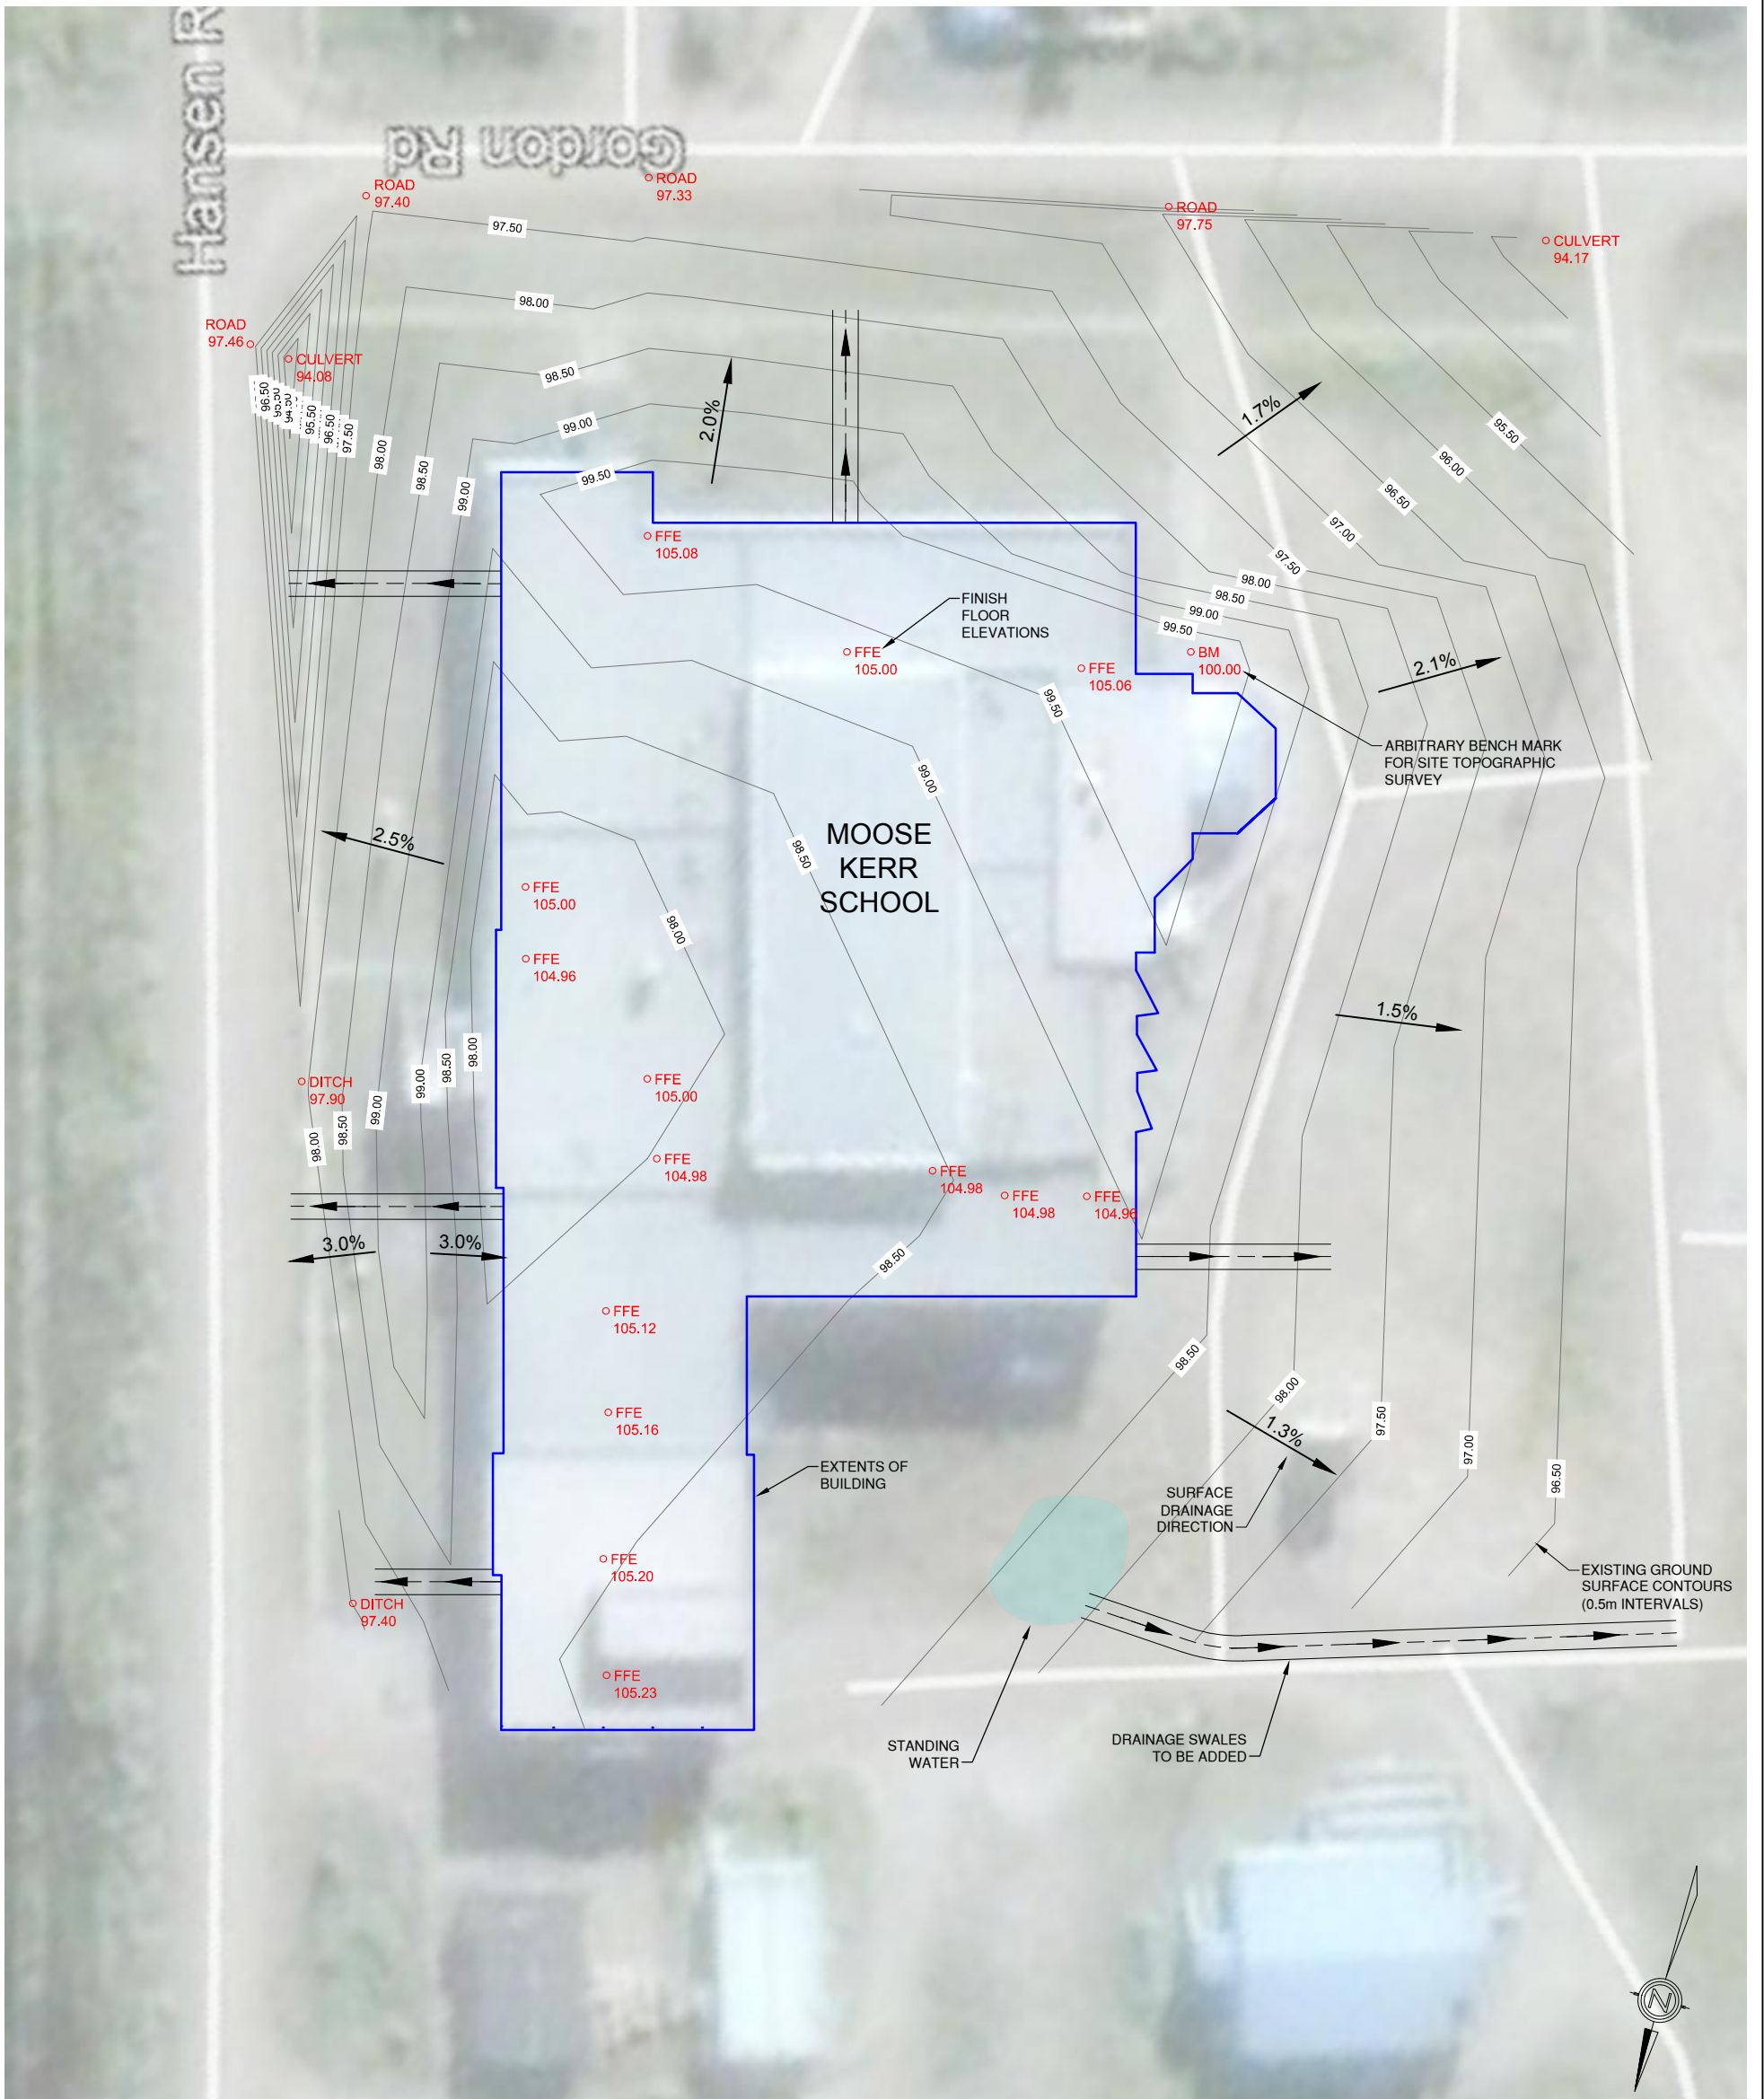
A		FOR REPORT		17/01/08
ISSUE		DRAWING STATUS / REVISION		(YYMMDD) DATE
DESIGNED	DRAWN	CHECKED	APPROVED	SCALE
JLH	JLH	JLH	MH	AS SHOWN
				SHEET SIZE
				11X17

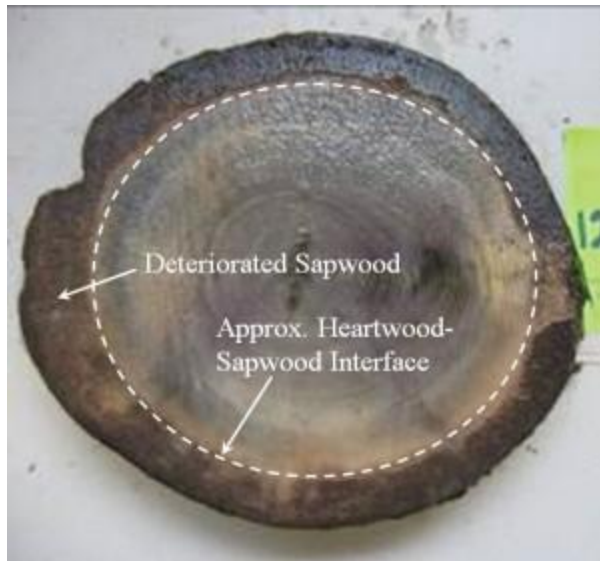
Figure 1: Deteriorated timber pile cross-section.

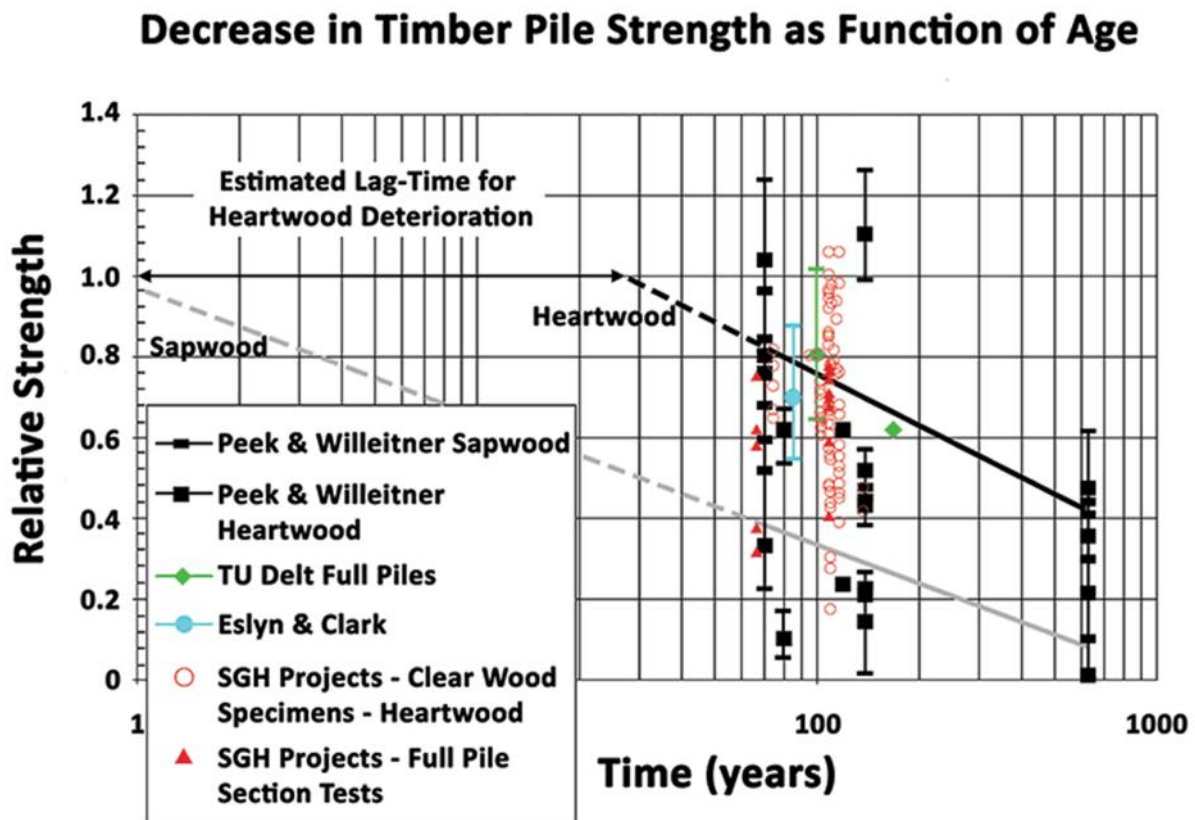
Figure 2: Decrease in timber pile compressive strength with in-service age (Base figure from Van Kuilen, 2007).

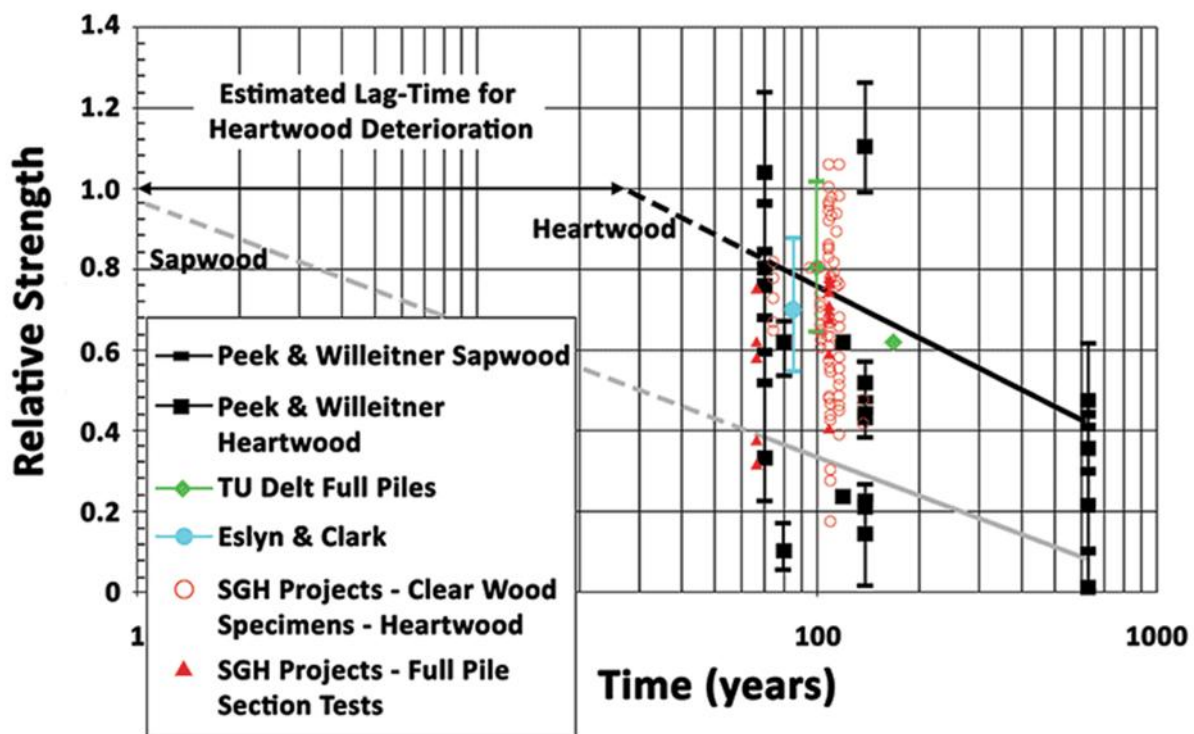
Figure 1: Decrease in timber pile compressive strength with in-service age (Base figure from Van Kuilen, 2007).

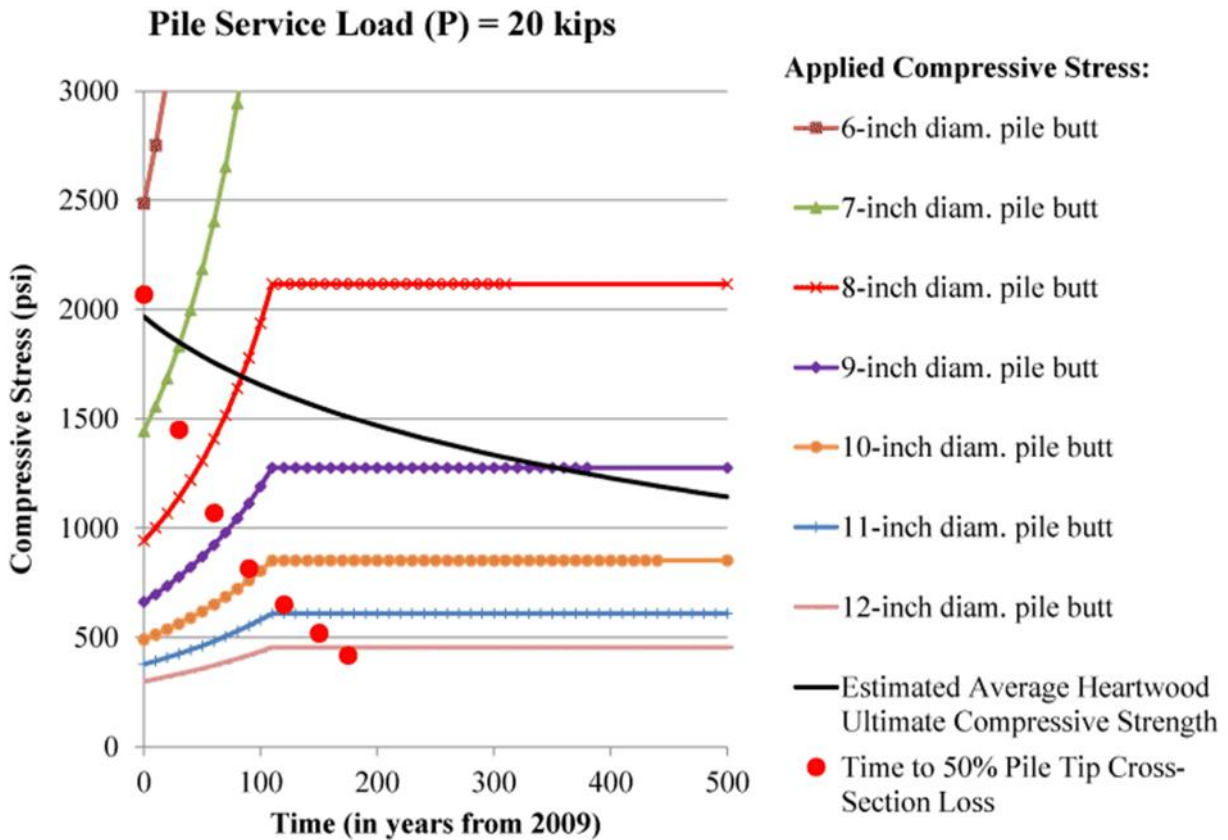
Figure 2: Sample plots of applied compressive stress and estimated heartwood compressive strength vs. time.

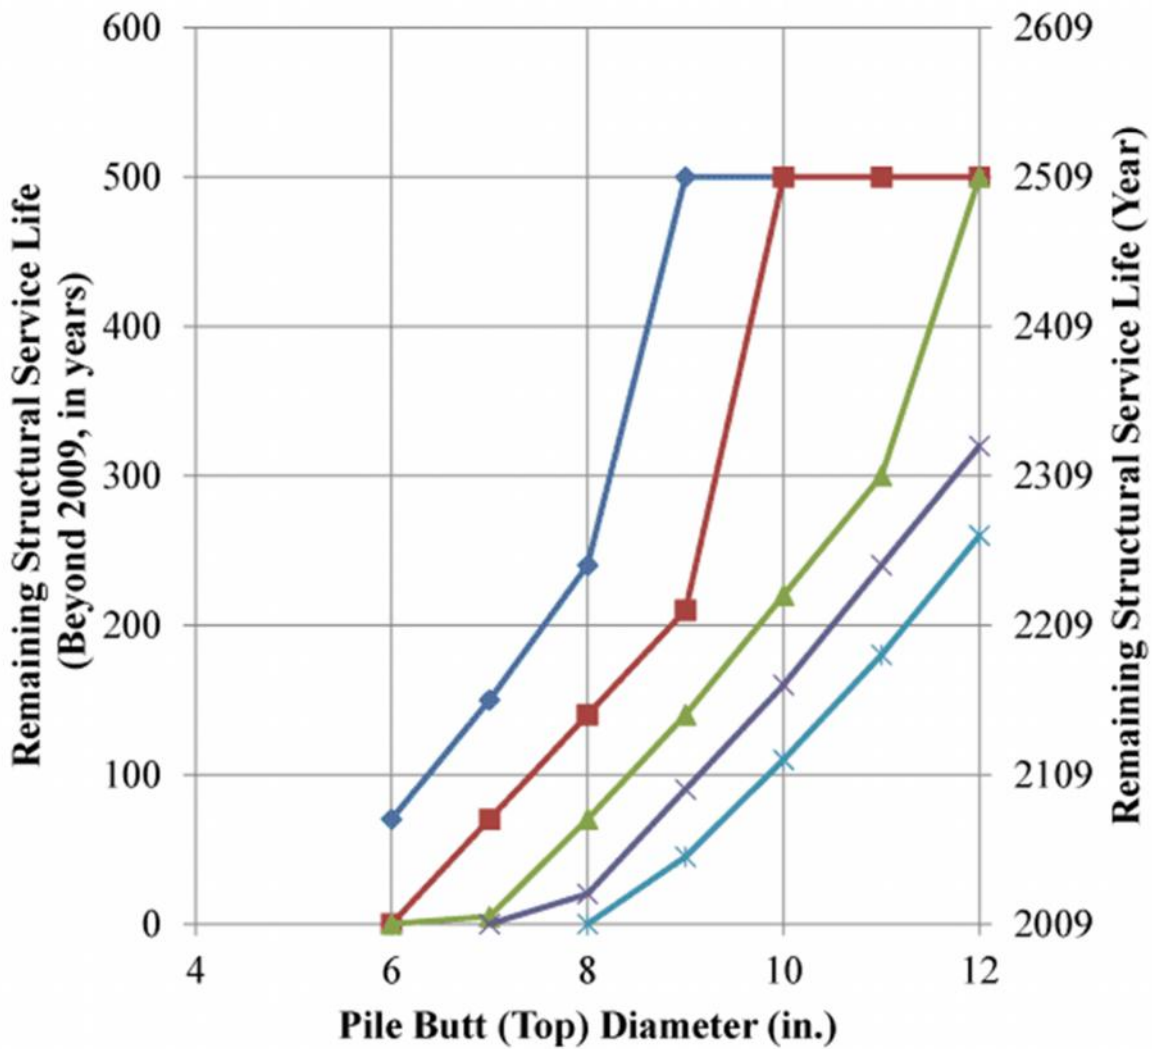
**P = Applied Service Load (per pile):**

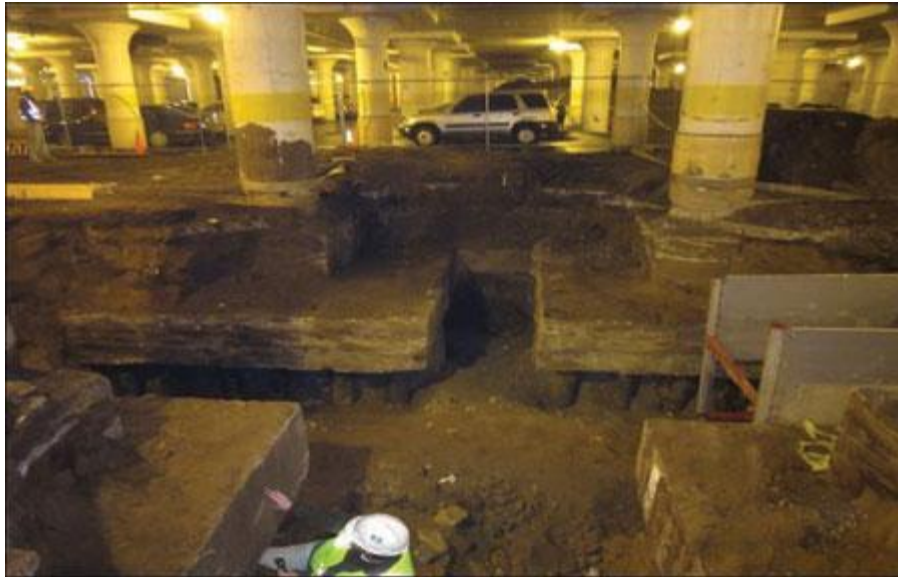
Figure 2. Overall view of track deck structure at first test pit excavation

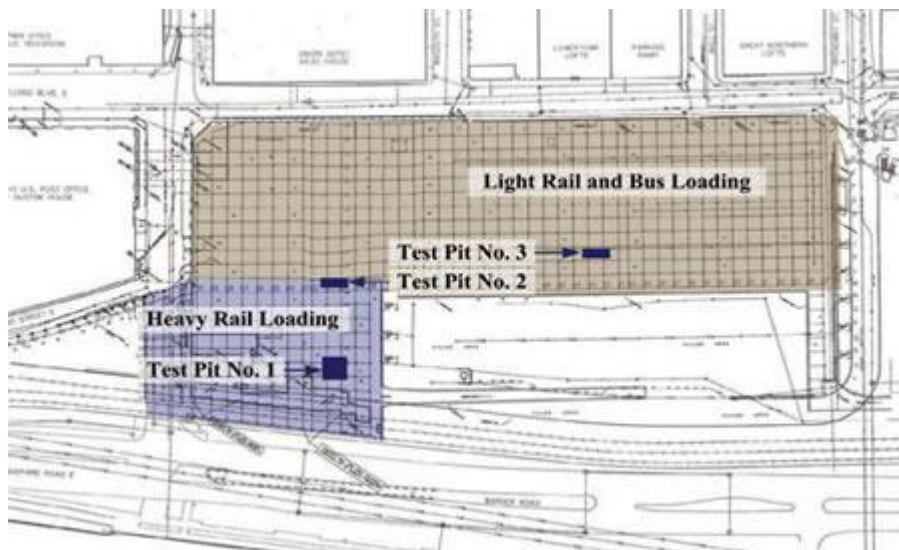
Figure B. Plan view of the track deck showing anticipated design loads and foundation test pit locations

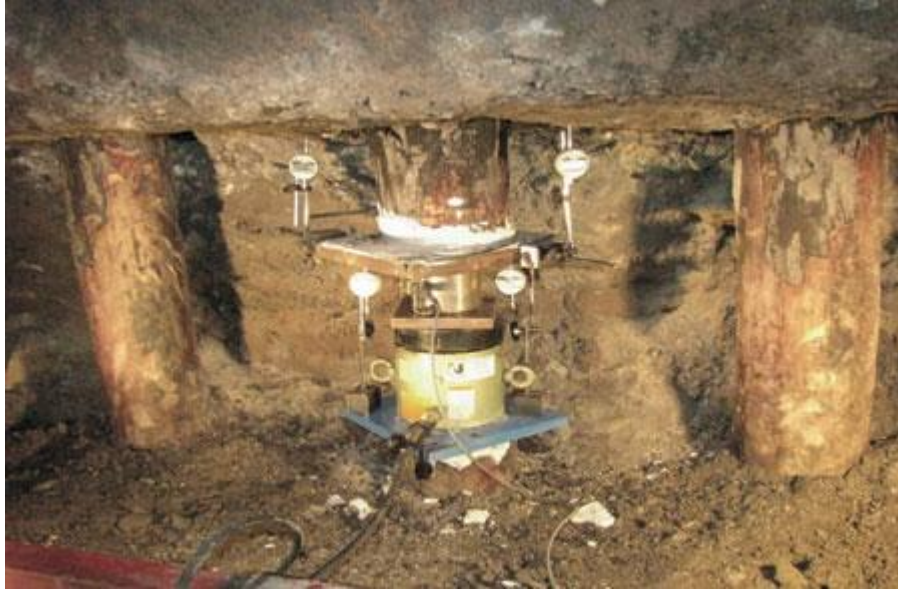
Figure 4. In-situ load testing of timber pile

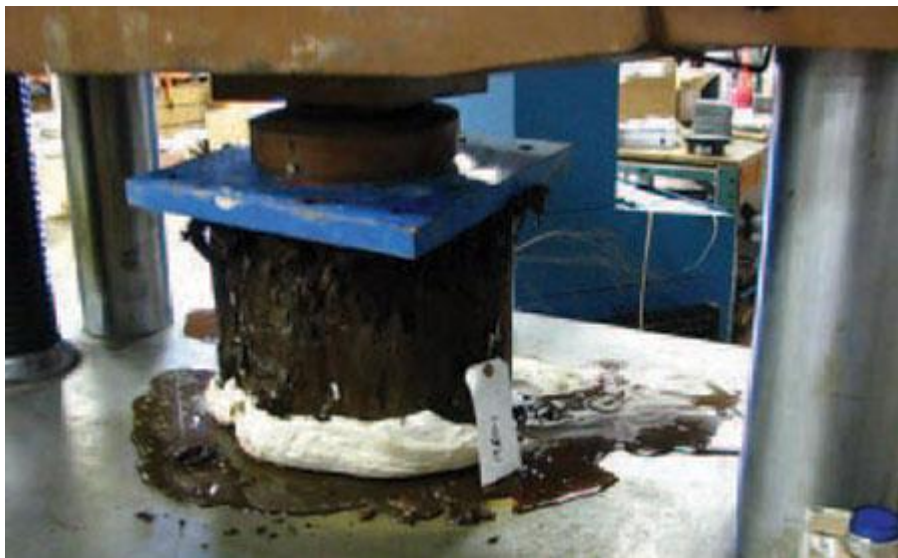
Figure 5. Laboratory load testing of decayed pile top

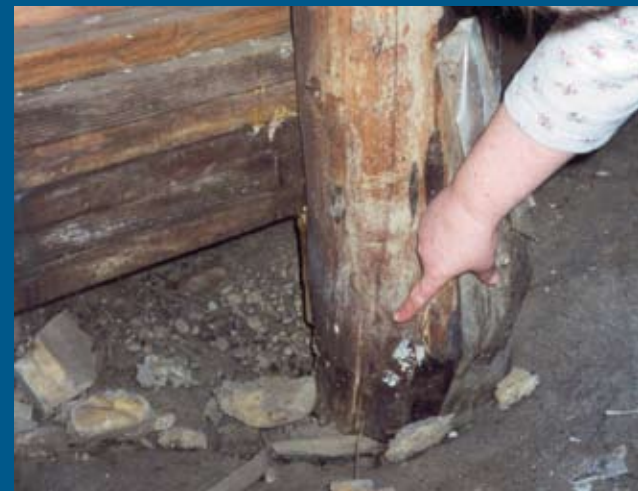
Depression holds water around pile, speeding up rot.

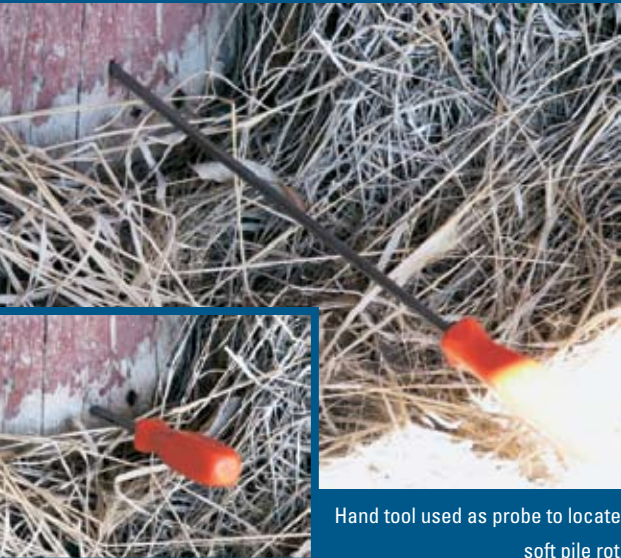
Hand tool used as probe to locate soft pile rot.

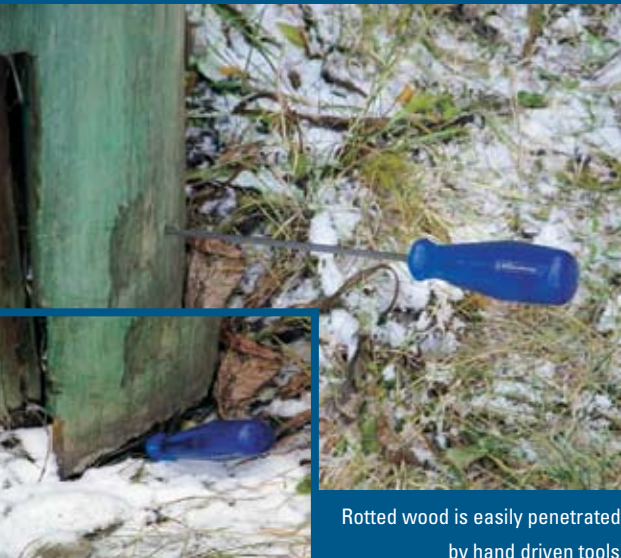
Rotted wood is easily penetrated by hand driven tools.

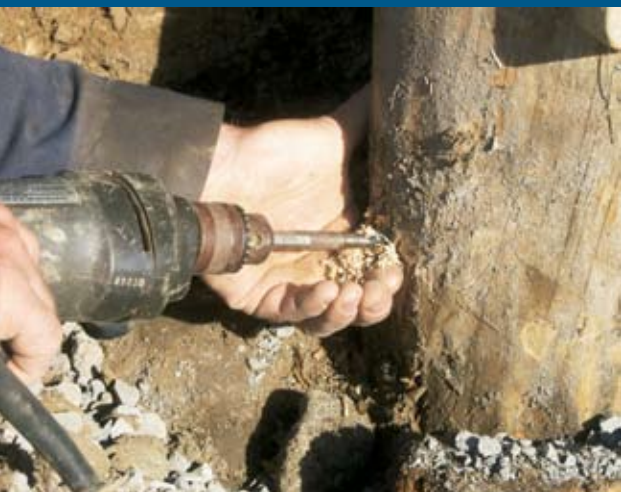
Sampling of pile interior allows detailed diagnosis of wood rot progress in a lab.

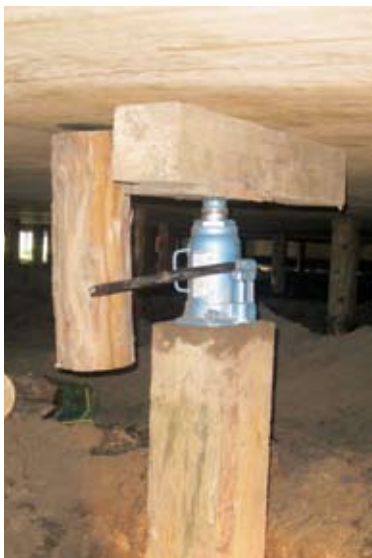
Temporary support allows new pile sections to be installed.

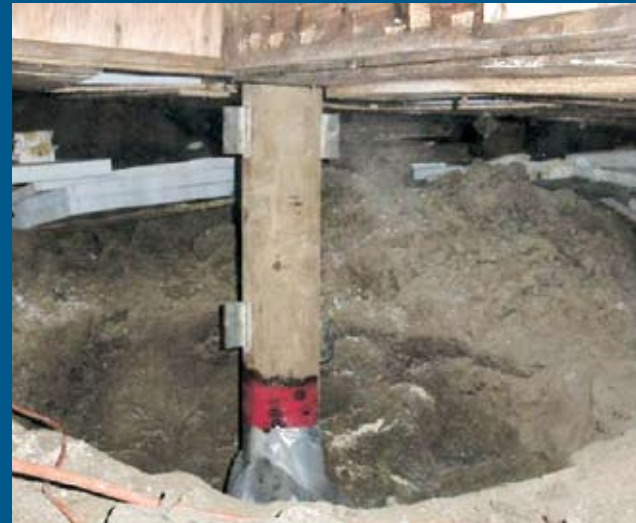
The rotted portion of this pile has been replaced with new material.

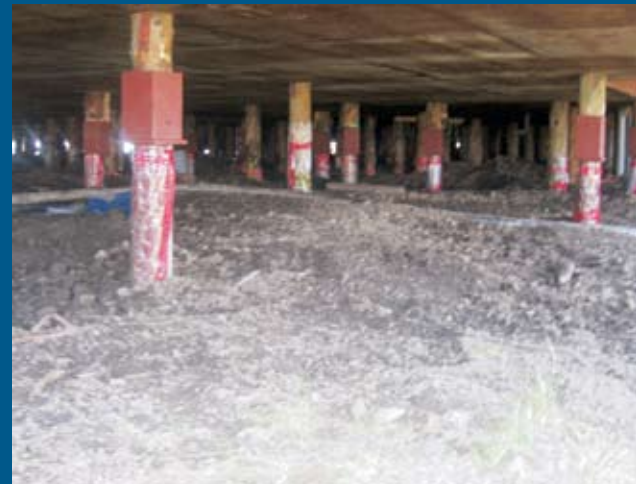
Steel sleeves connect new piles to solid portions of original piles.

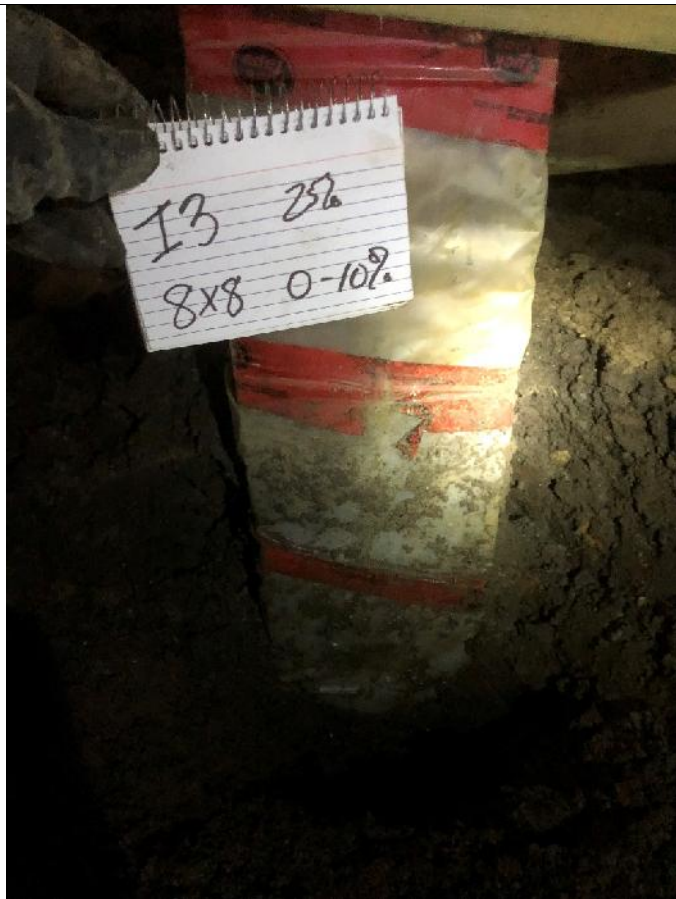
Typical exterior pile repaired with steel cap.

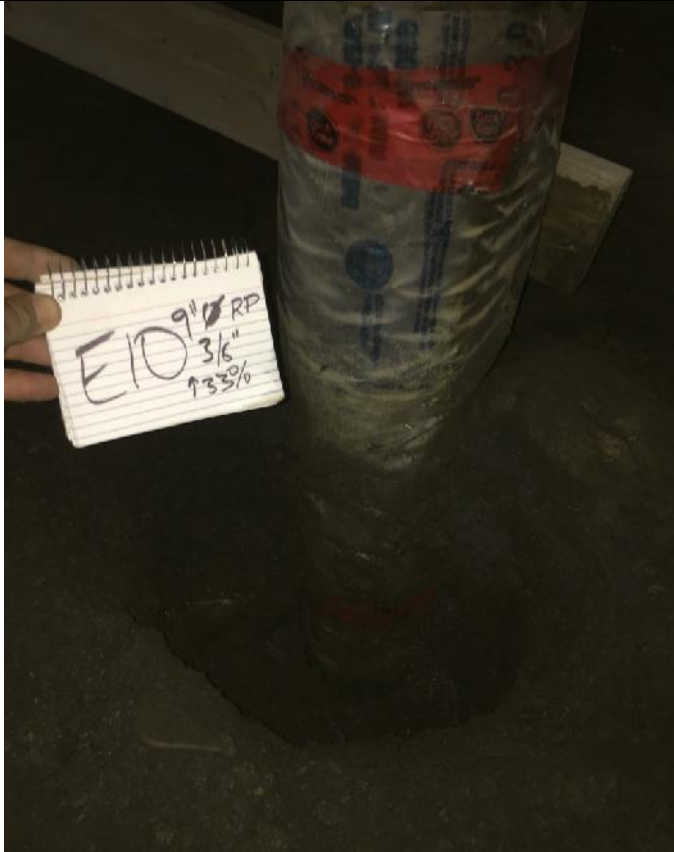
Typical 8"x8" wood repaired pile. Piles are plastic wrapped and taped to keep moisture out.

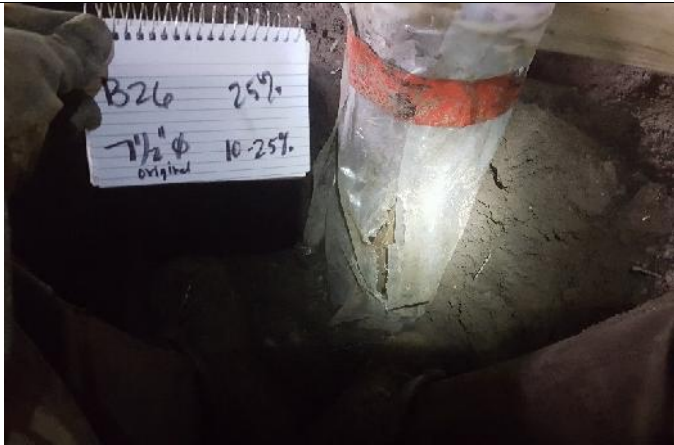
Typical original round wood timber pile.

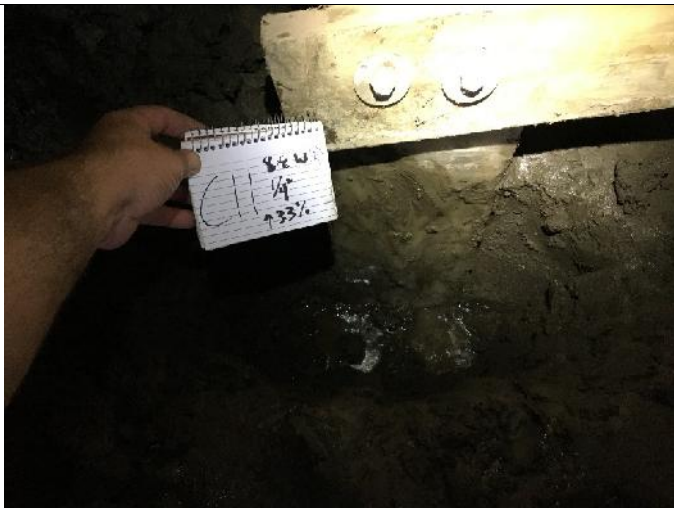
Pile B26 – Requires surface repair

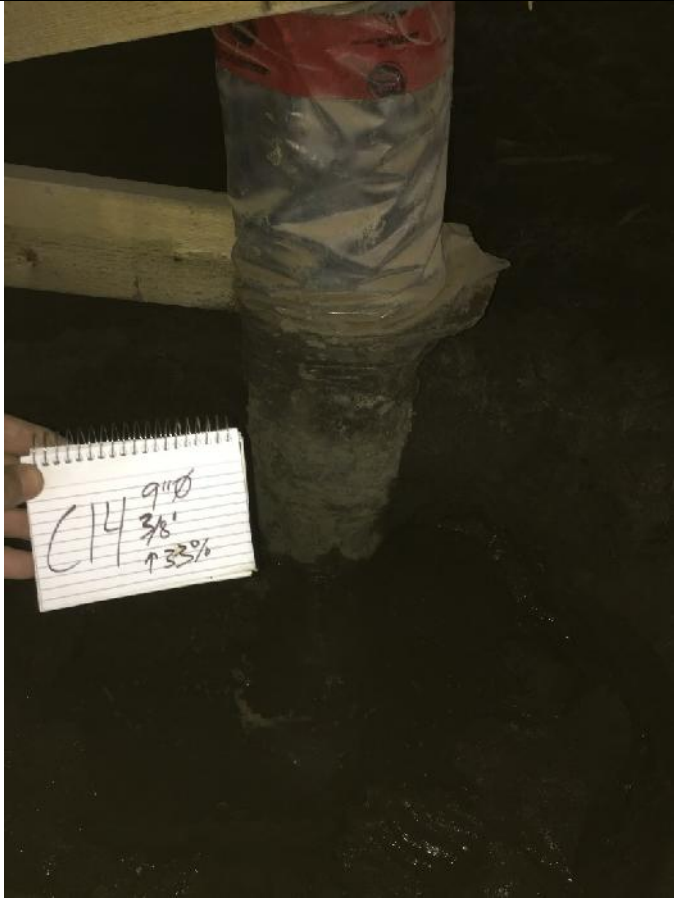
Pile C11 – Requires surface repair

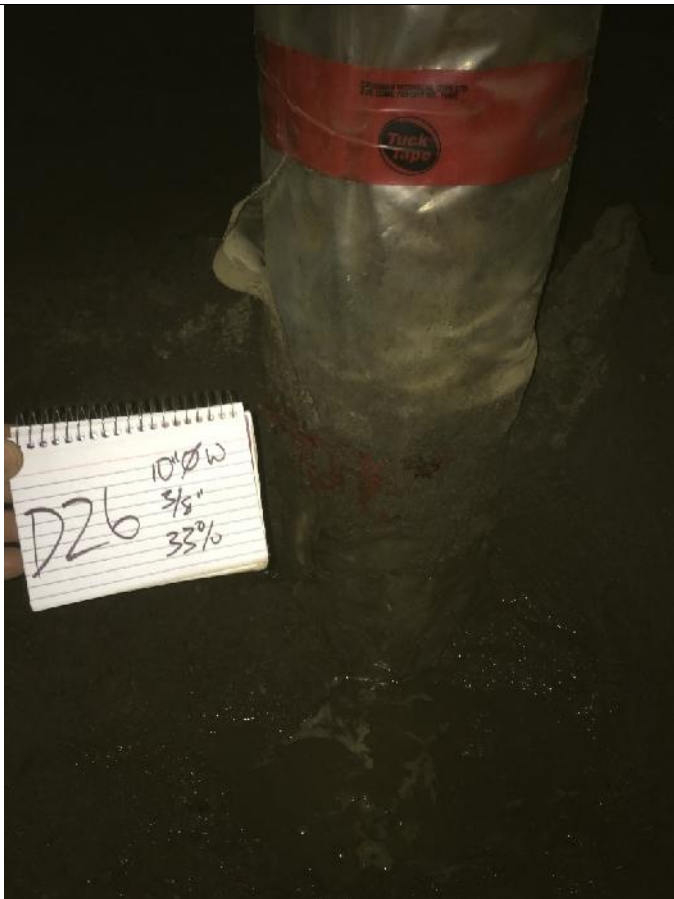
Pile C14 – Requires surface repair

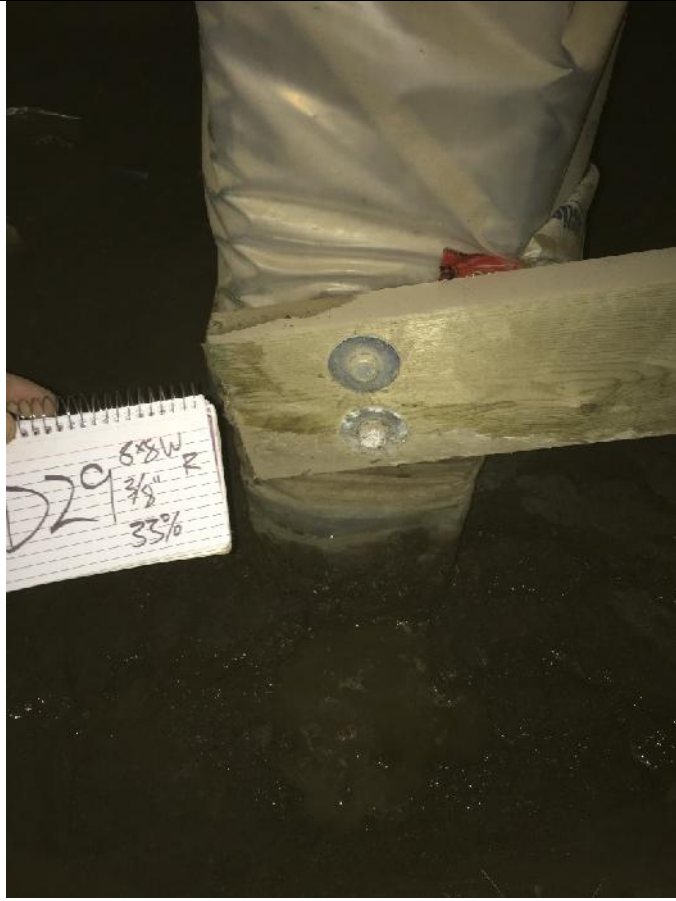
Pile D26 – Requires surface repair

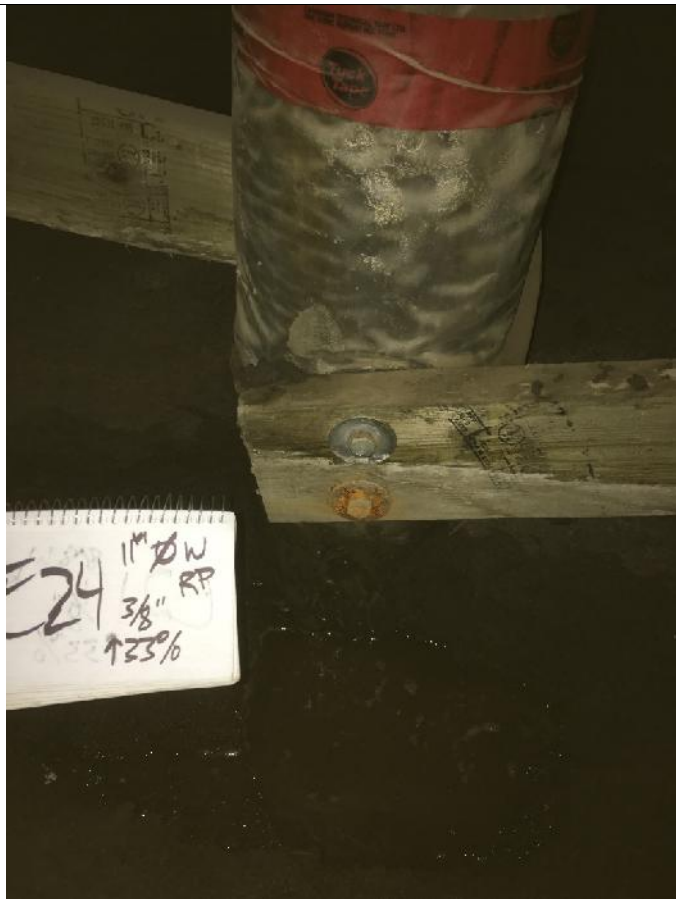
Pile D29 – Requires surface repair

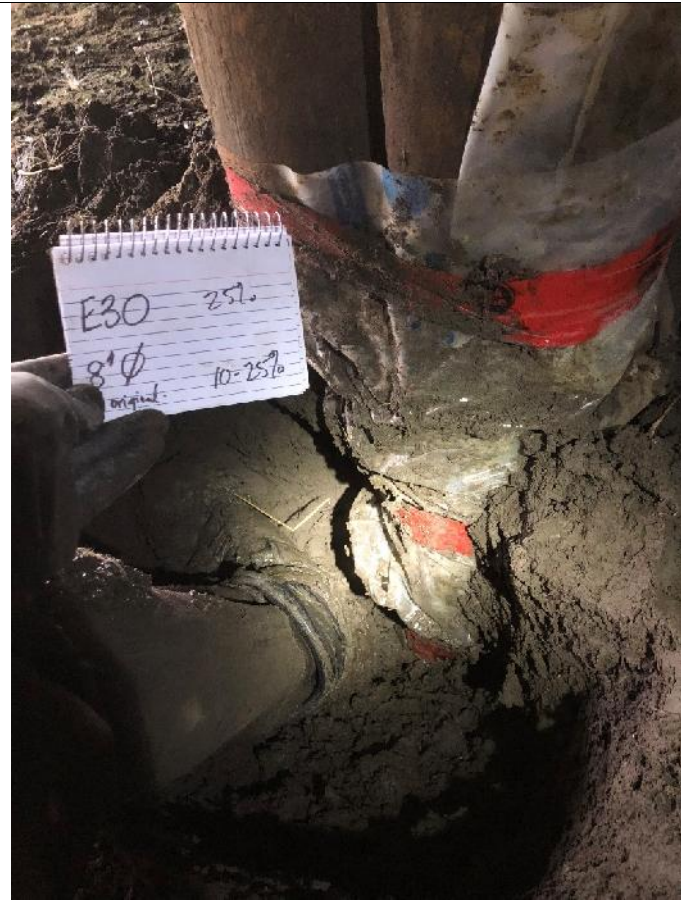
Pile E24 – Requires surface repair

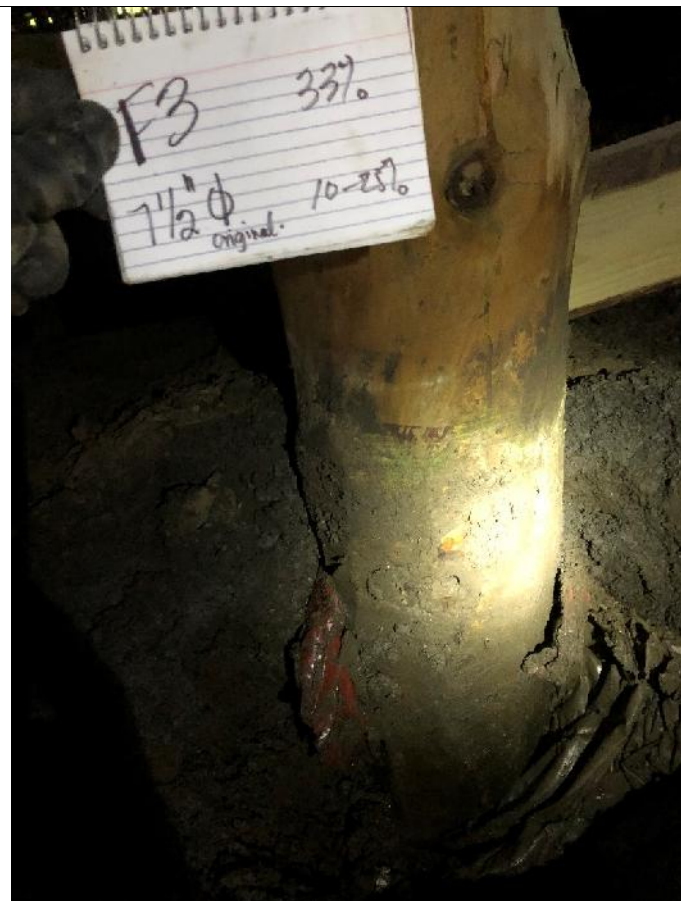
Pile E30 – Requires surface repair

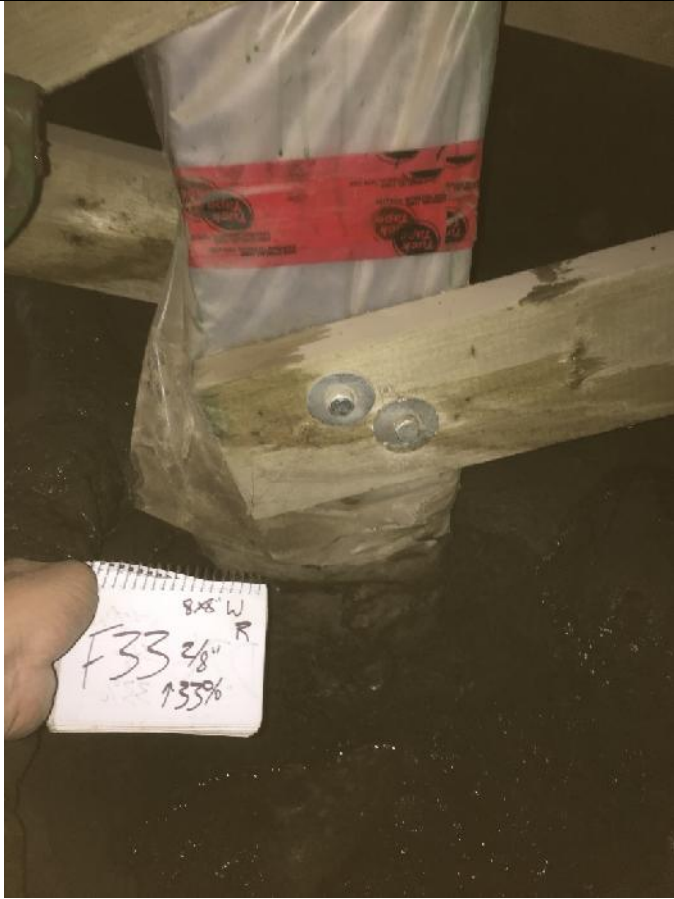
Pile F3 – Requires surface repair

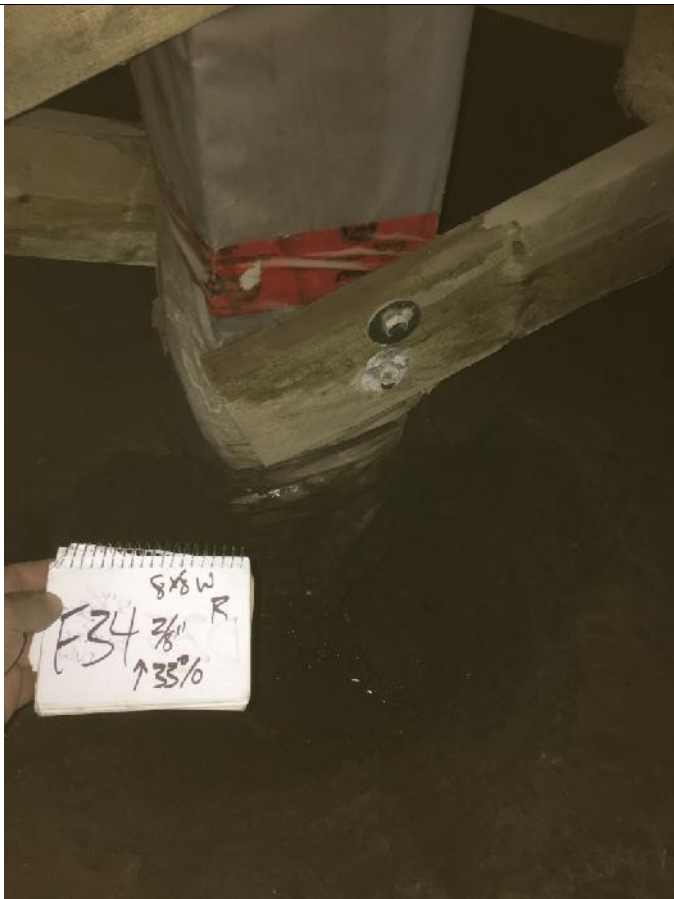
Pile F33 – Requires surface repair
