Contract ID: SC-INF01-1469  
Our File #: 18-304

**Sanayut Consulting Professional  
Engineers Corporation**

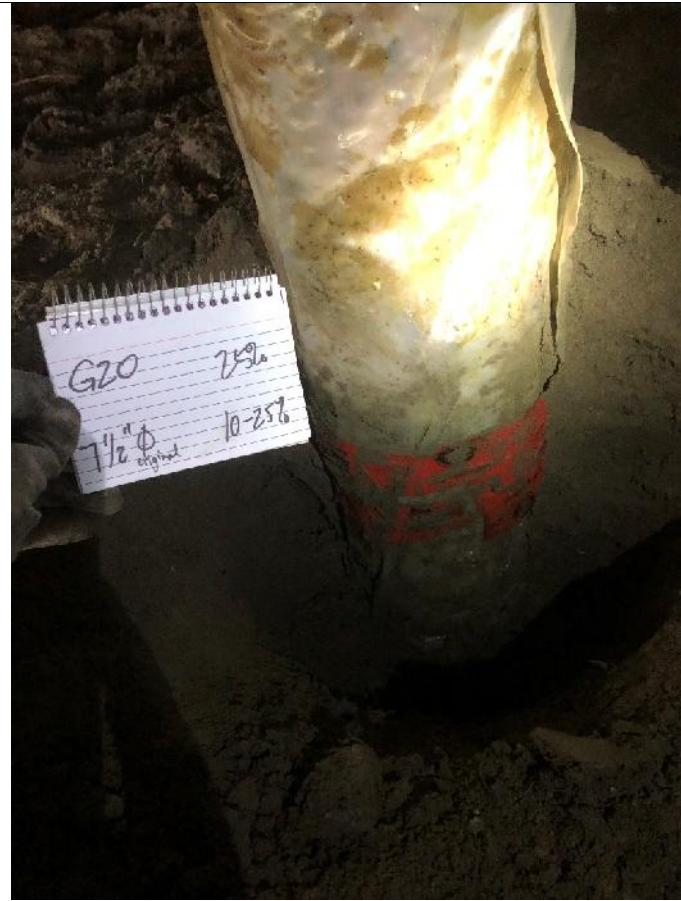
Pile F34 – Requires surface repair

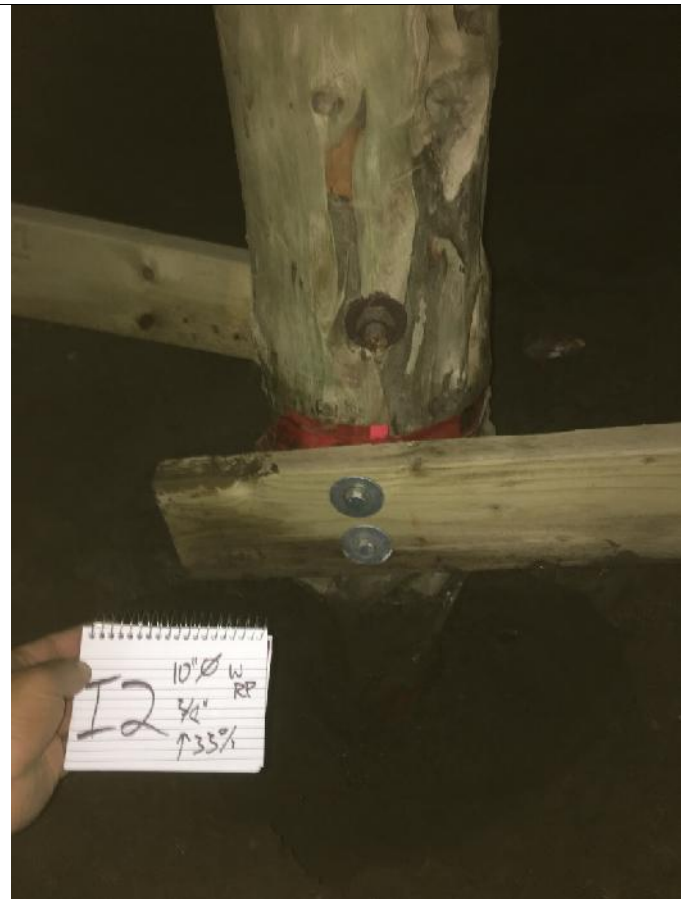
Pile G20 – Requires surface repair

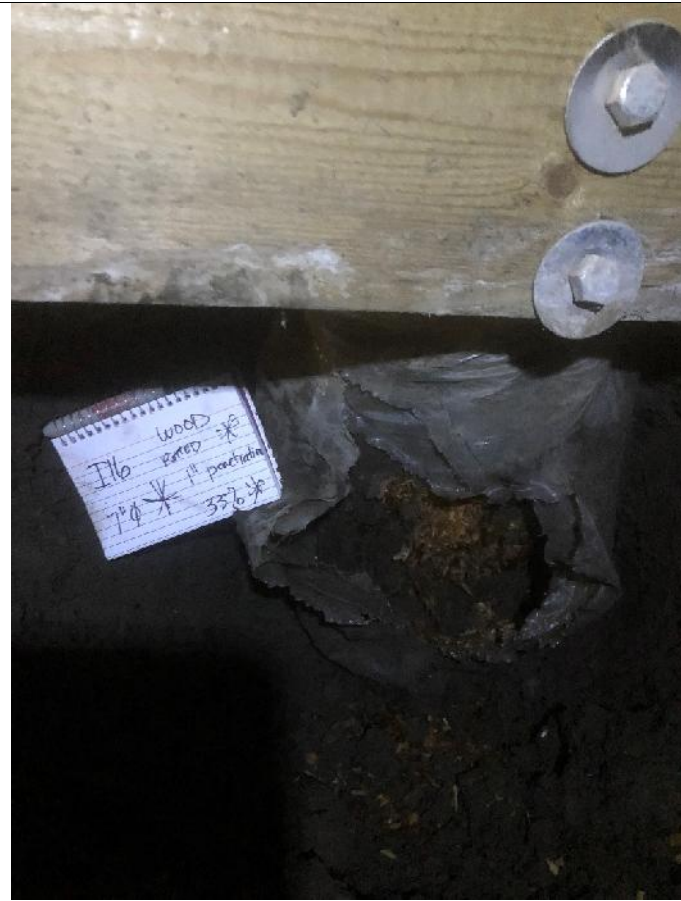
Pile I2 – Requires surface repair

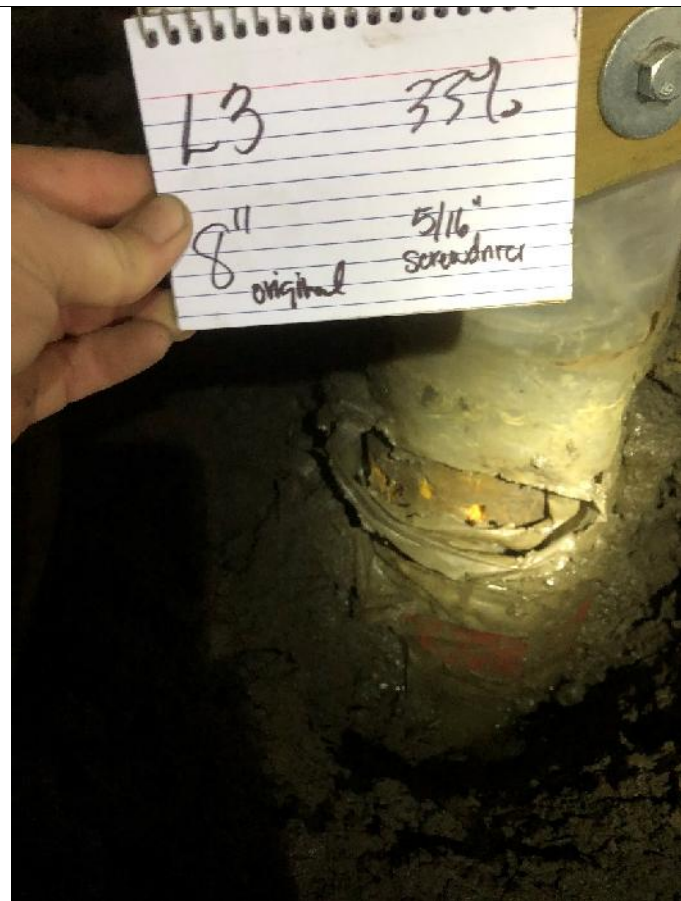
Pile I16 – Requires full repair

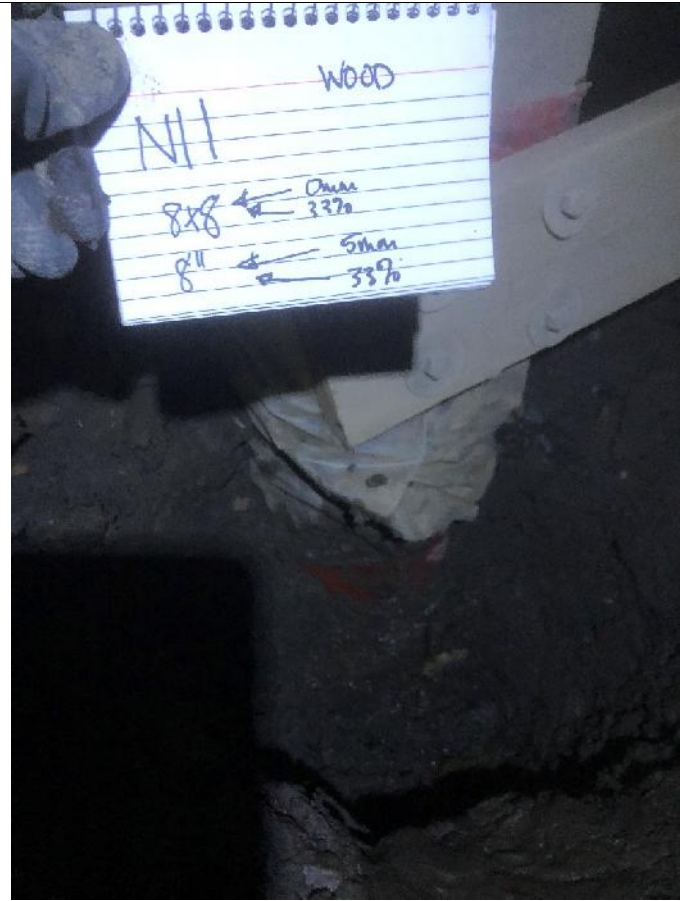
Pile I13 – Requires surface repair

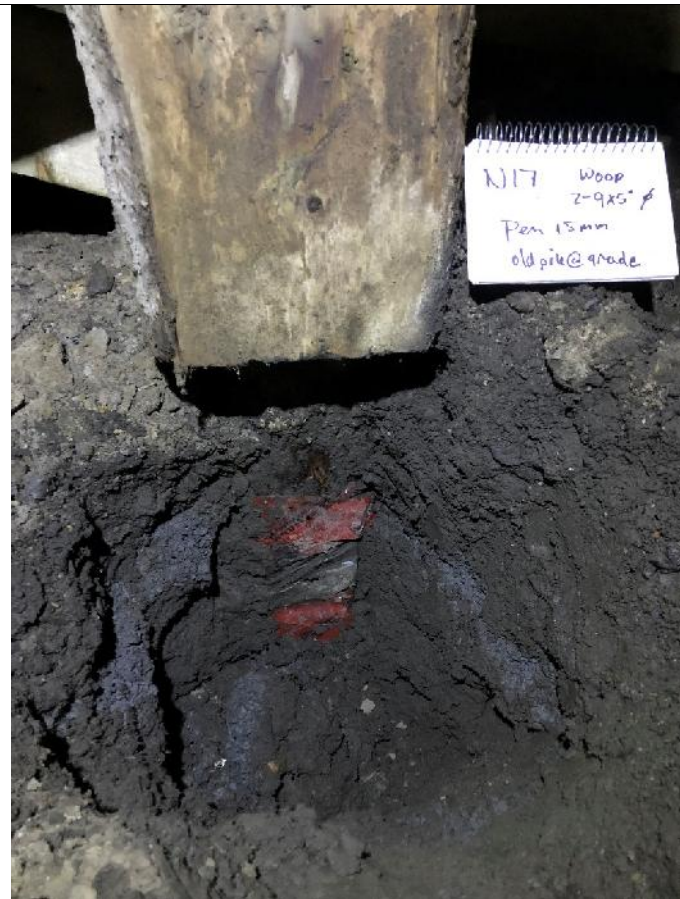
Pile N11 – Requires surface repair

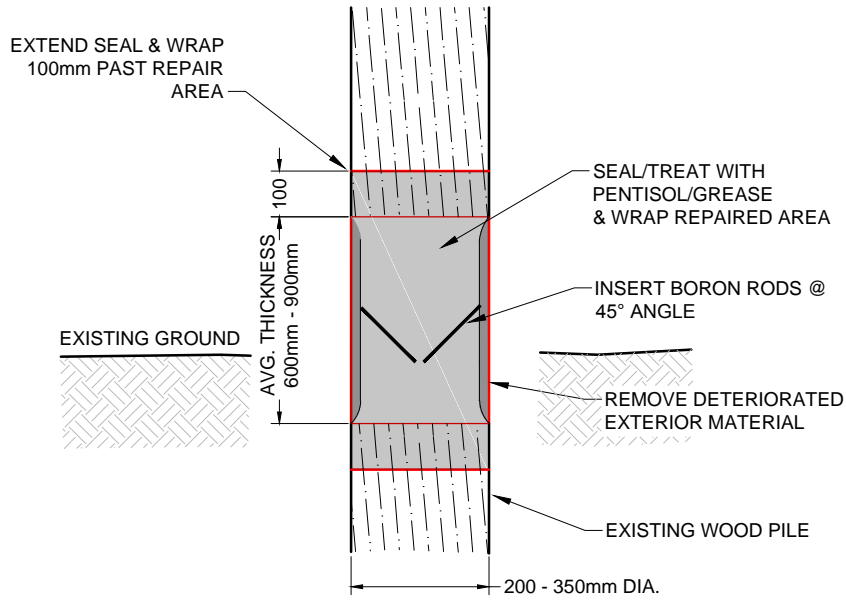
DETAIL A - TYPICAL REPAIR  
SCALE: NTS

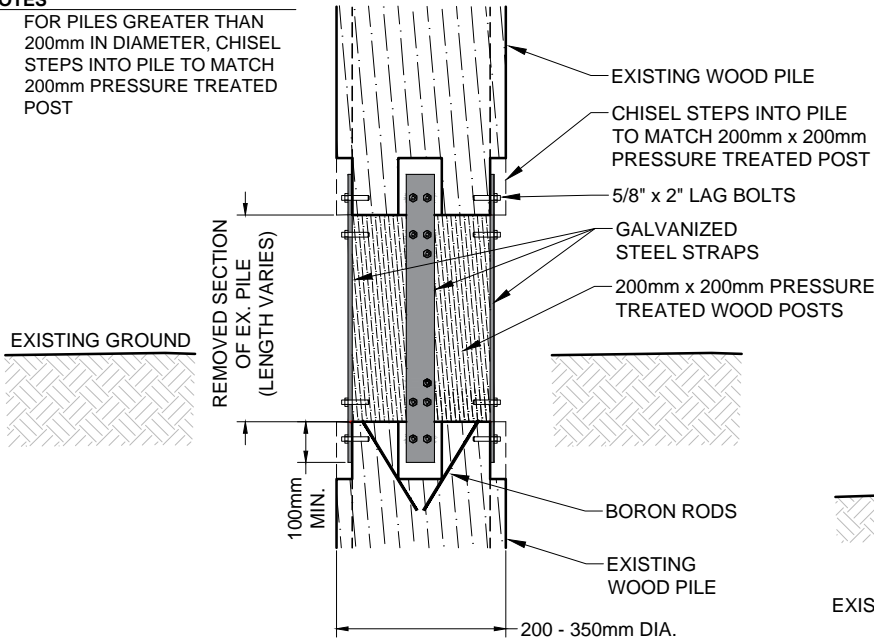
DETAIL B - REPLACEMENT OPTION 1  
SCALE: NTS

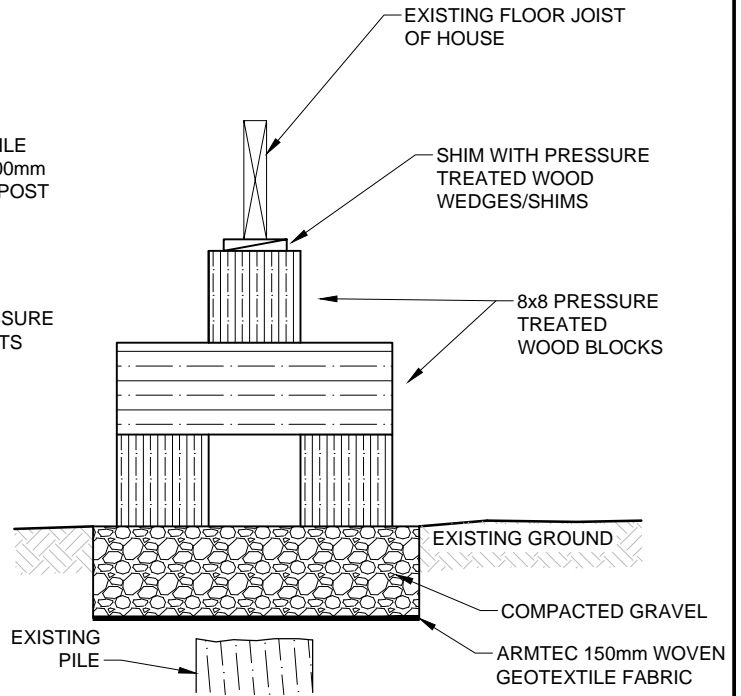
DETAIL C - REPLACEMENT OPTION 2  
SCALE: NTS
