Contract ID: SC-INF01-1469
Our File #: 18-304

Reliance Group Home Foundation Pile Condition Assessment

August 31, 2018

Regarding: Reliance Group Home Foundation Pile Condition Assessment
Location: #26 Reliance Street, Inuvik, NT

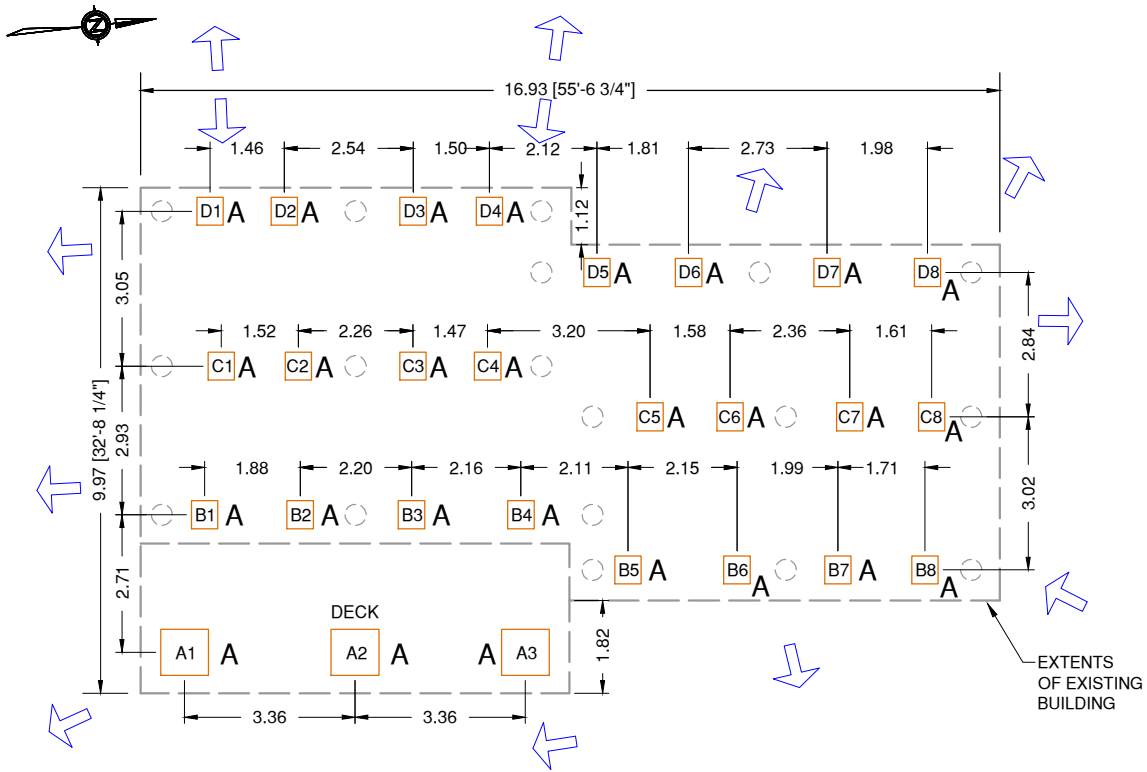
TYPICAL BLOCKING DETAIL

The results of the site inspection showed that all of the existing wood piles have 33% or higher loss of cross-sectional integrity and all require full repair. There is blocking between all the existing piles supporting the beams which make up the structural framework for the building. The wood blocking is in good condition with no rot or deterioration observed. There was no standing water observed under or around the building. The overland drainage appears to flow from the north down towards the south and east and no pooling or ponding was observed.

Definition - Blocking Condition	Range of Rot	Count in each range	Percentage in each Range
A	Little or no rot detected, No repair req'd	0 - 10%	27	100%
B	Rotted, requires monitoring	10 - 25%	0	0%
C	Rotted, requires repair	25 - 50%	0	0%
D	Rotted, requires immediate blocking	50 to 100%	0	0%

The investigation found that all eighteen of the existing wood piles have already been replaced with 24 block and wedge foundations and there were three new block and wedge foundations under the deck. These foundations are functioning as designed.
