Contract ID: SC-INF01-1469  
Our File #: 18-304

## **Fort McPherson Health Centre Foundation Pile Condition Assessment**

**Regarding: Fort McPherson Health Center Foundation Pile Condition Assessment**  
**Location: Lot 7 Block 1 Plan 2823, Fort McPherson, NT**

An assessment of the pile foundation of the Health Centre building located at Lot 7 Block 1 Plan 2823 in Fort McPherson was conducted on June 22, 2018.

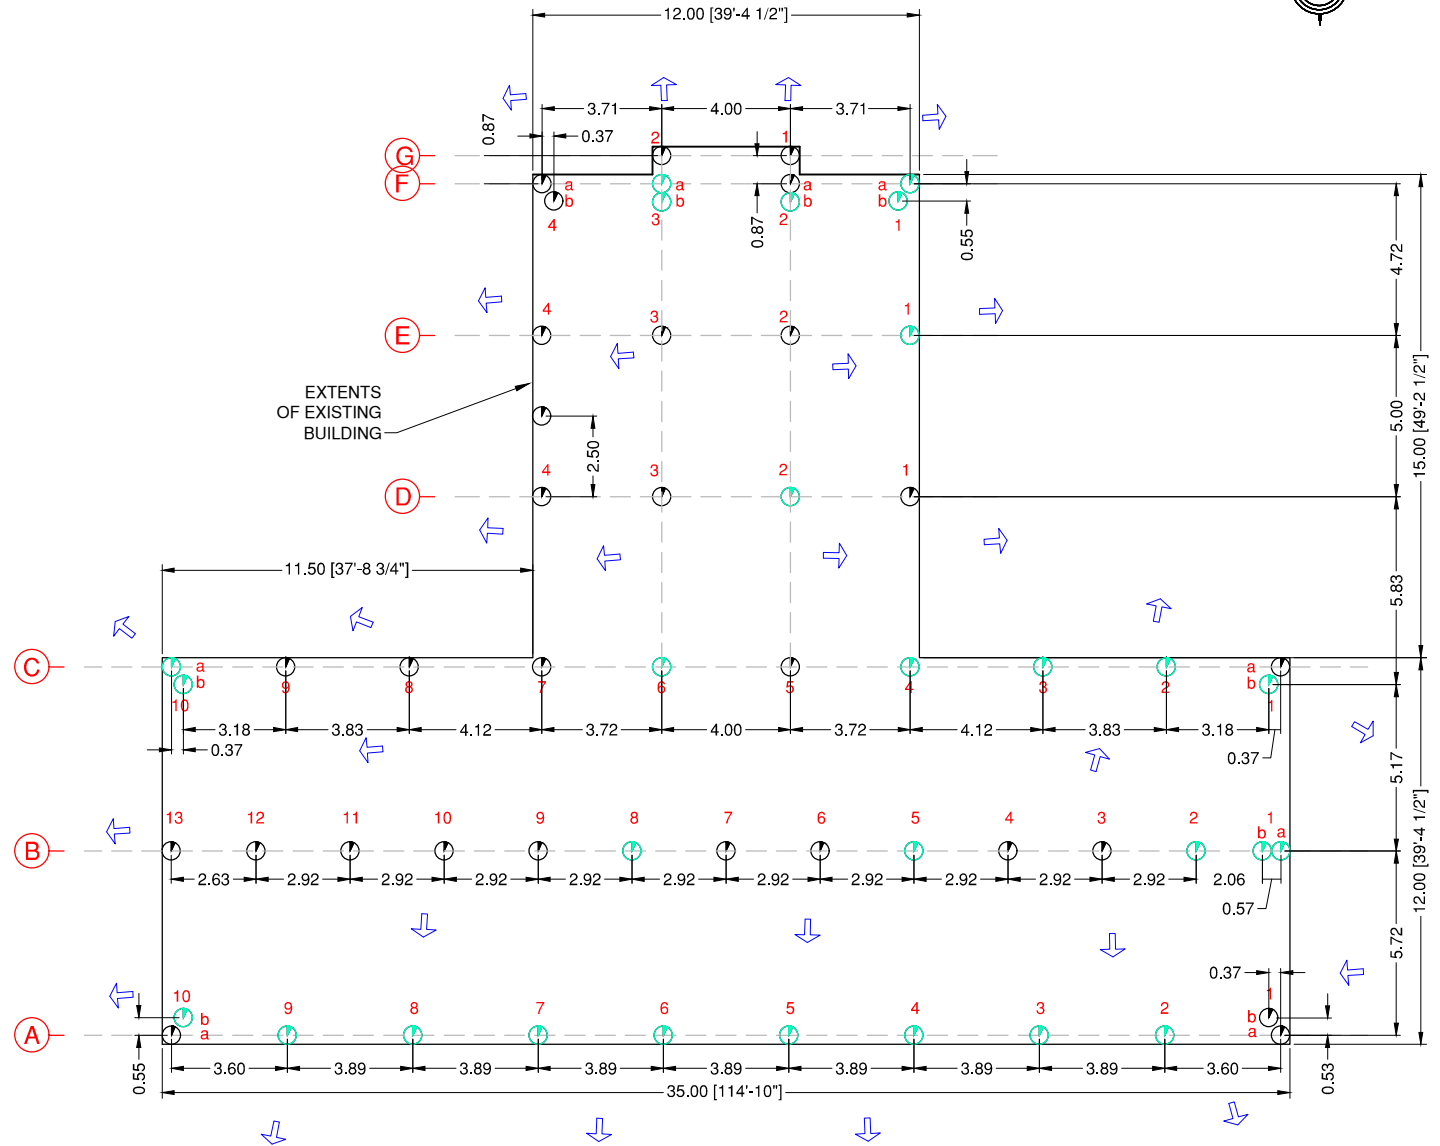
The health centre building rests on 57 wood piles located under the building footprint. Twenty-nine of the piles are original while the remaining 28 piles have been repaired with 8"x8" square wooden posts. The original timber piles range in size from 7" to 10" in diameter. Some of the repaired piles have been cross braced to the existing piles with 2x8s which have been bolted laterally (refer to [Appendix B-Photographs](#)). The dimensions and pile spacings are shown on [Figure 1](#), [Appendix A](#) and further described in subsequent sections.

The health center building currently rests on 57 piles consisting of both original wood piles and new 8"x8" wood sections (refer to [Figure 1](#)). The ground around each pile was excavated to a maximum depth of 500mm below ground ensuring that each pile was sufficiently exposed for inspection. Penetration and moisture tests were performed on each pile with the results showing no penetration, and low moisture content overall. The grading under the building directs surface water away from the centre of the building ensuring that there is no ponding or standing water beneath the building. The overland drainage appears to flow in all directions away from the building. Drainage classification for this site regarding impact to foundation piles is mild.
