Contract ID: SC-INF01-1469
Our File #:18-304

ENR Bunkhouse Foundation Pile Condition Assessment

Regarding: ENR Bunkhouse Foundation Pile Condition Assessment
Location: Lot 4 Block 91, Inuvik, NT

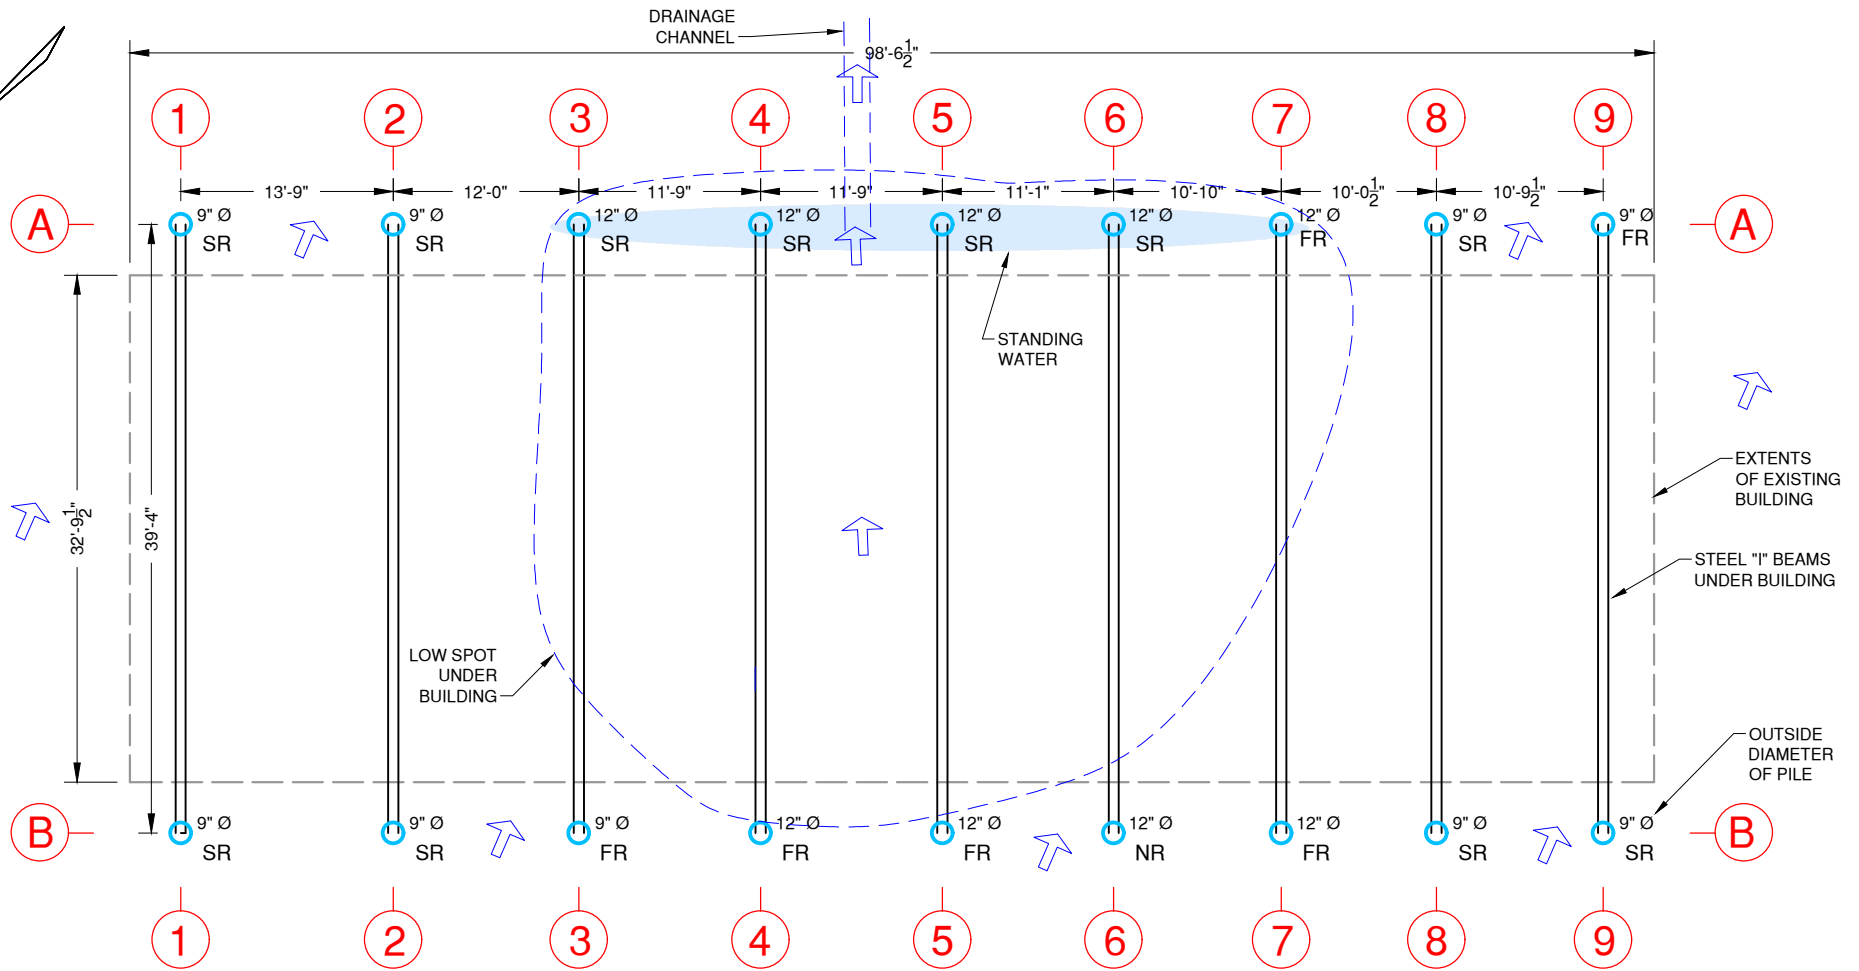
PROJECT NUMBER	18-304
VERSION NUMBER	IFA1-1
DATE DRAWN	JULY 4, 2018
SHEET NUMBER	FIG. 1

The results of the site inspection showed that each steel pile had minimal surface rust with no penetration except for piles A7, A9, B3-5, and B7 which had flaking rust. The drainage appears to flow from the north down towards the south and southeast. There was some standing water observed around piles A3 – A7 along the back (east side) of the building in the depression beneath the building.

The results of this report indicate that the steel piles are in relatively good condition with only surface rust observed on the majority of the piles. Piles A7, A9, B3-5, and B7 showed some flaking rust beneath the ground surface. Based on this analysis the foundation appears to be performing as designed and no repair actions are recommended at this time.

It is recommended that the low area around the piles and beneath the building be filled to resolve the issue of standing water under the building and around the piles at the rear of the building.
