Contract ID: SC-INF01-1469  
Our File #: 18-304

## **INF Carpentry Shop Foundation Pile Condition Assessment**

**Regarding: INF Carpentry Shop**  
**Location: 40 Veterans Way, Inuvik, NT**

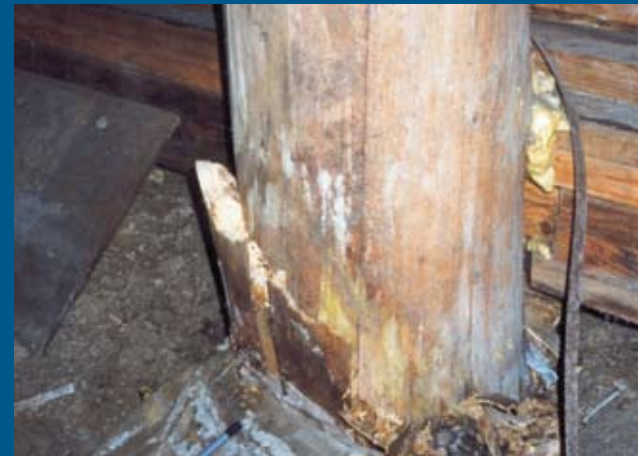
Total Pile collapse at Ground level.
