**Sanayut Consulting Professional
Engineers Corporation**

Deline Health Centre Foundation Pile Condition Assessment

Regarding: Deline Health Centre-Foundation Pile Condition Assessment
Location: Lots 3 – 6, Plan 5182, Deline, NT

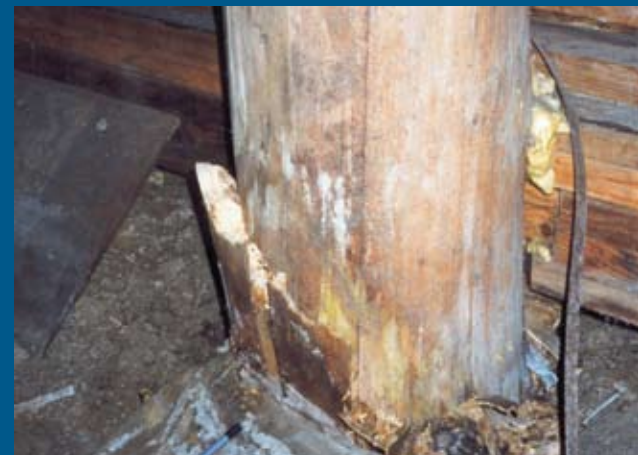
Total Pile collapse at Ground level.

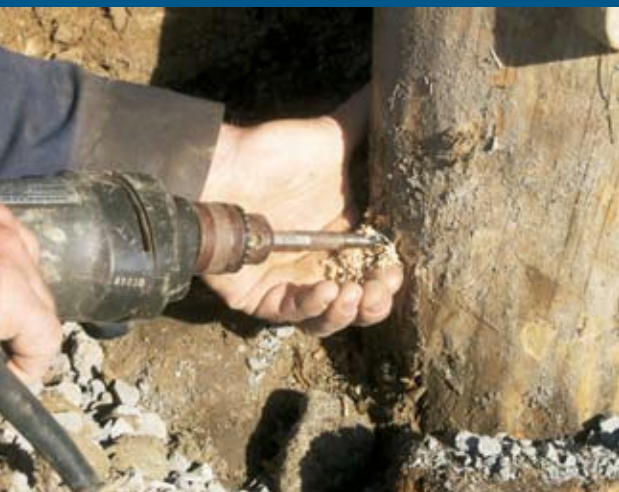
Sampling of pile interior allows detailed diagnosis of wood rot progress in a lab.

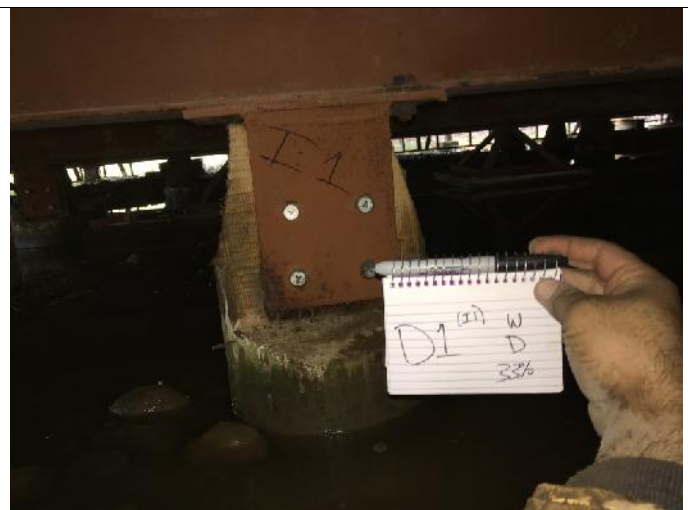
D3 – Incorrectly labelled as D1

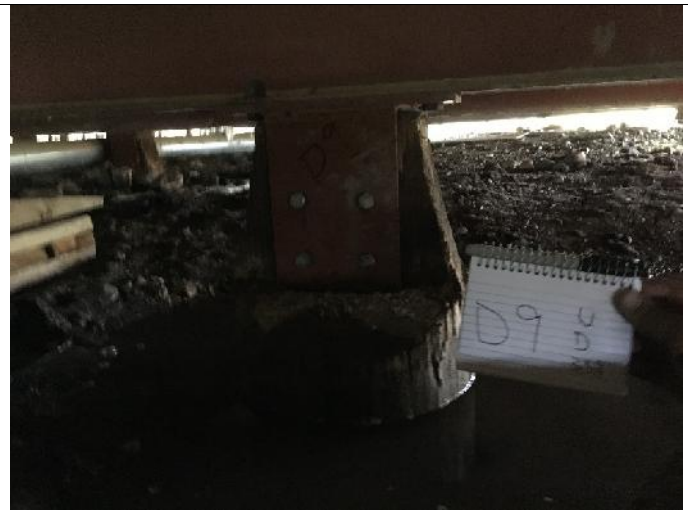
E9 – Incorrectly labelled as D9

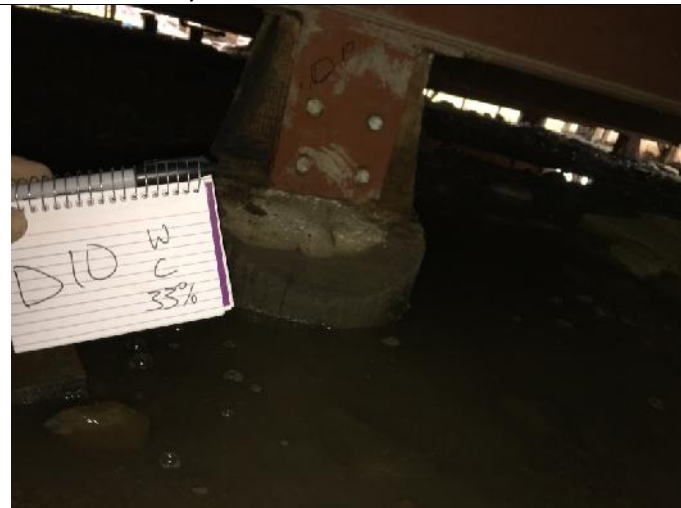
E10 – Incorrectly labelled as D10

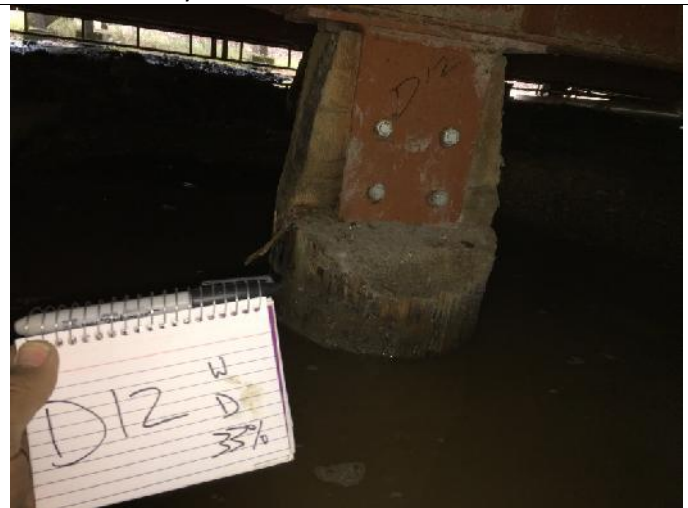
E12 – Incorrectly labelled as D12

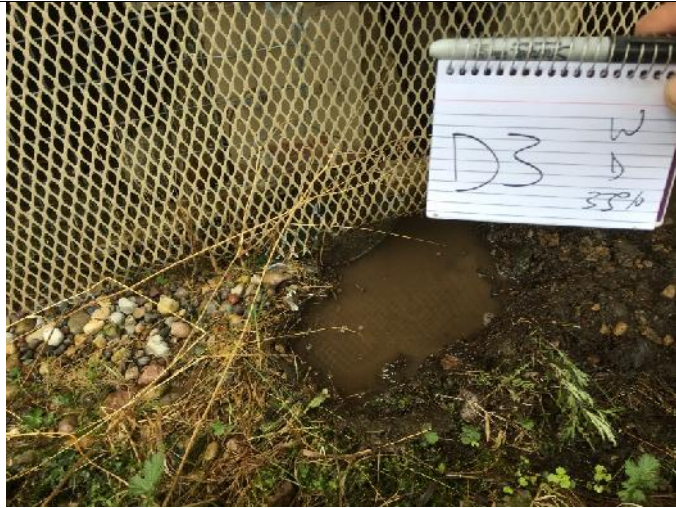
H3 – Incorrectly labelled as D3

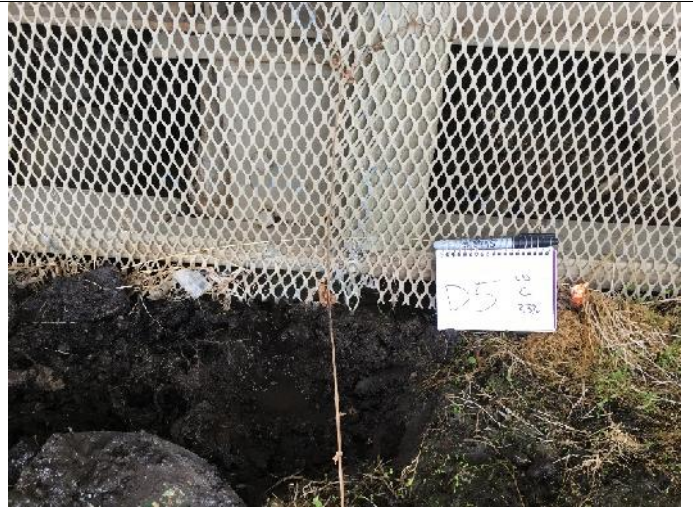
E5 – Incorrectly labelled as D5

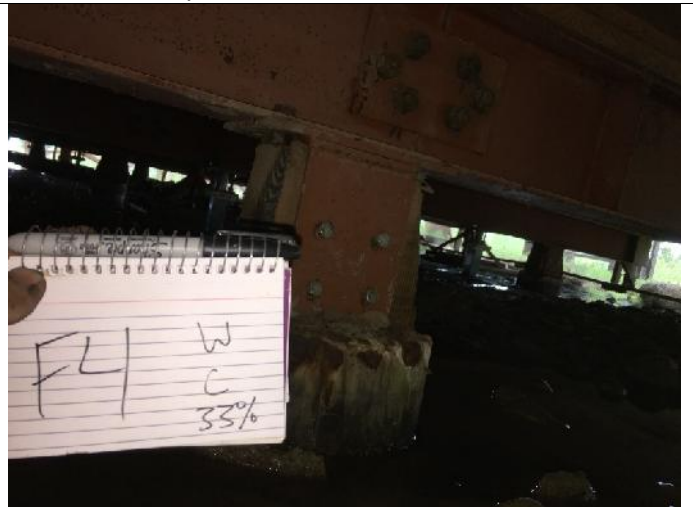
G2 – Incorrectly labelled as F4
