Contract ID: SC-INF01-1469  
Our File #: 18-304

## **Old MACA Warehouse Foundation Pile Condition Assessment**

**Regarding: Old MACA Warehouse**  
**Location: 43 Veterans Way, Inuvik, NT**

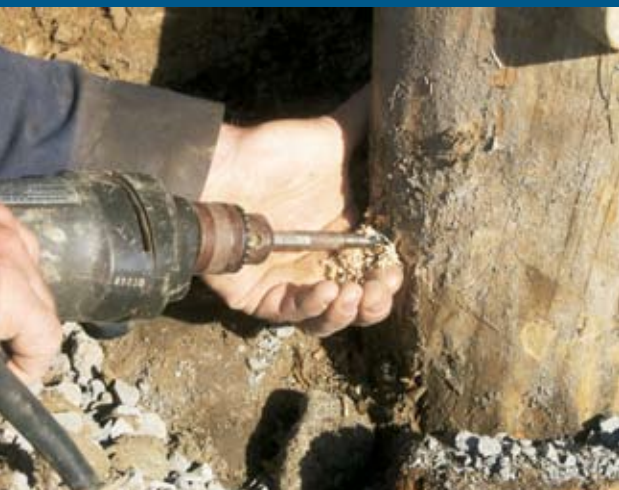
Sampling of pile interior allows detailed diagnosis of wood rot progress in a lab.
