**Sanayut Consulting Professional
Engineers Corporation**

Deline Health Centre Foundation Pile Condition Assessment

Regarding: Deline Health Centre-Foundation Pile Condition Assessment
Location: Lots 3 – 6, Plan 5182, Deline, NT

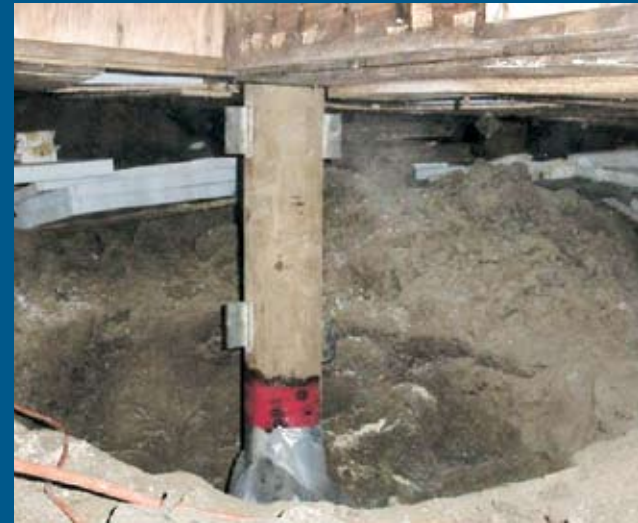
The rotted portion of this pile has been replaced with new material.

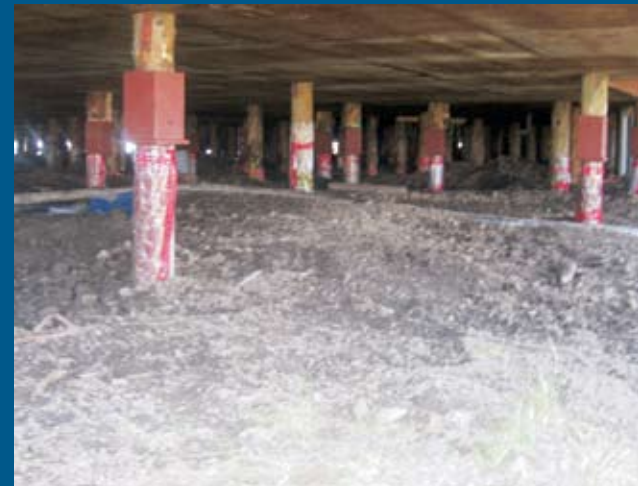
Steel sleeves connect new piles to solid portions of original piles.

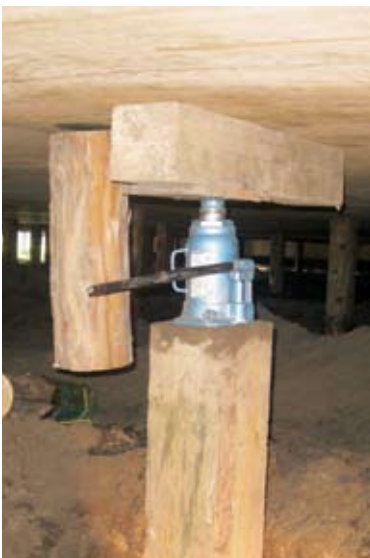
Temporary support allows new pile sections to be installed.

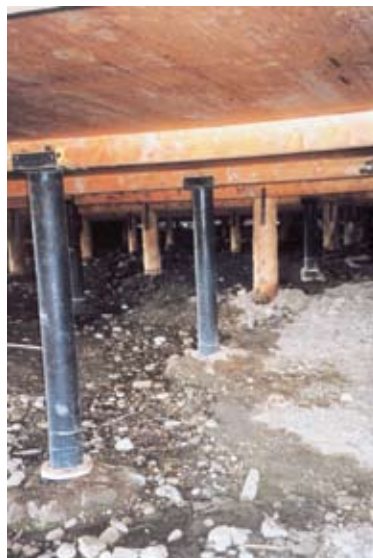
New steel posts connect solid piles below the earth to the building.

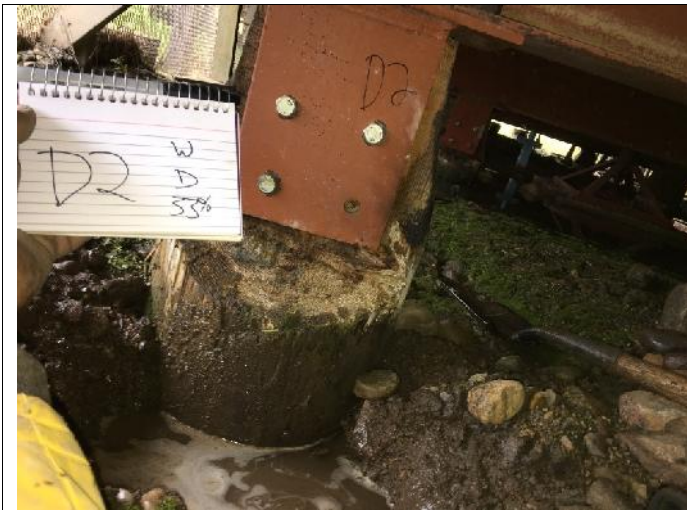
D4 – Incorrectly labelled as D2

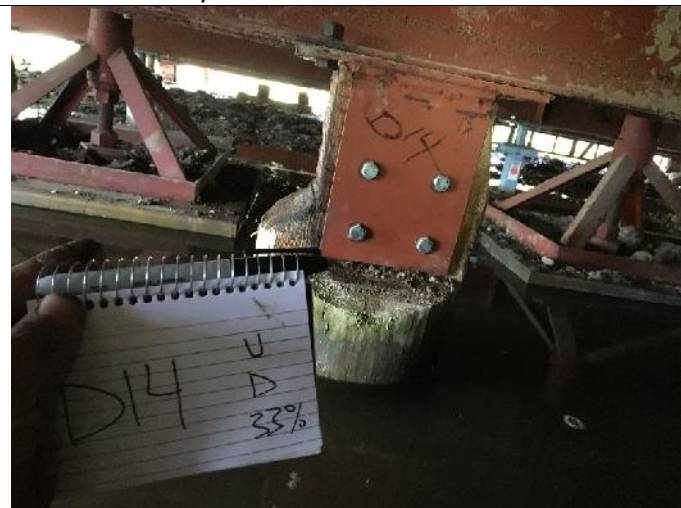
E14 – Incorrectly labelled as D14

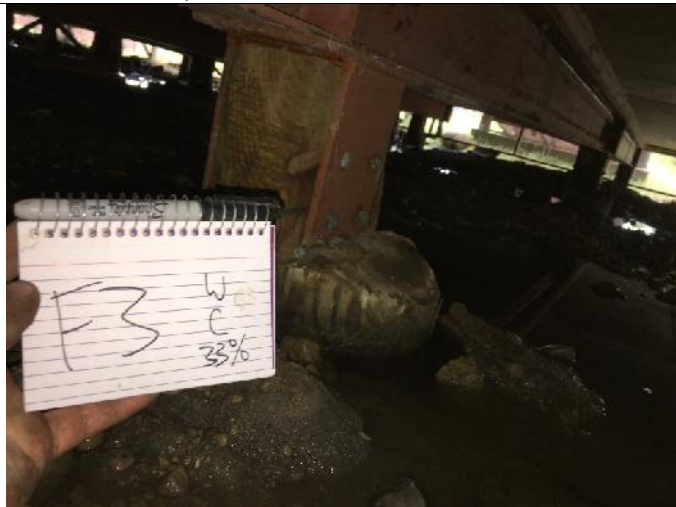
G3 – Incorrectly labelled as F3

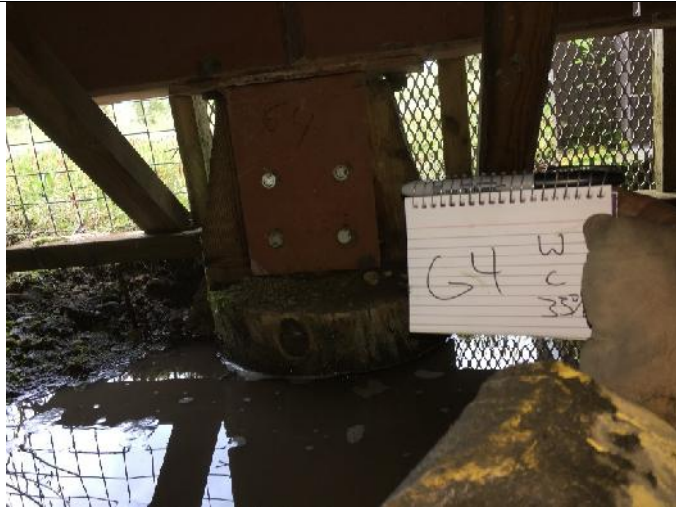
H4 – Incorrectly labelled as H4
